Access Compliance Report

Public Rights-of-Way

(Curb Ramps)

Intersection ID: 8592	Main Street: PERIWINKLE_HILL_AV	Cross Street: IKEA_BV	Location:	N
ADA ID: 316D6A146C83	Ramp Type: Directional1	Initial Pass/Fail: Fail	Overall Compliance: No	Severity Score: 12.5

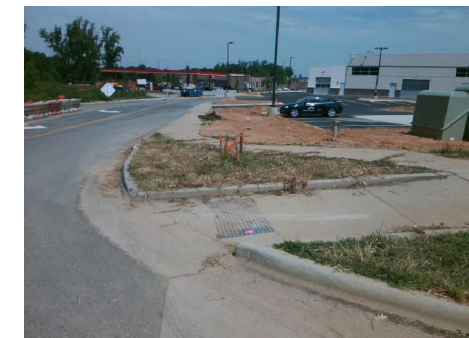
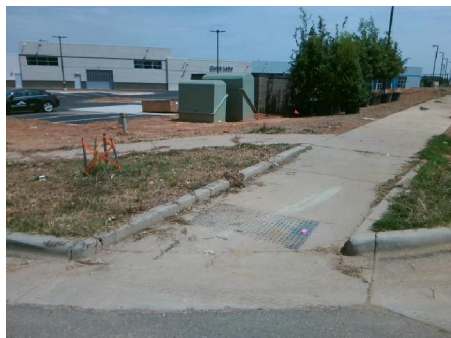
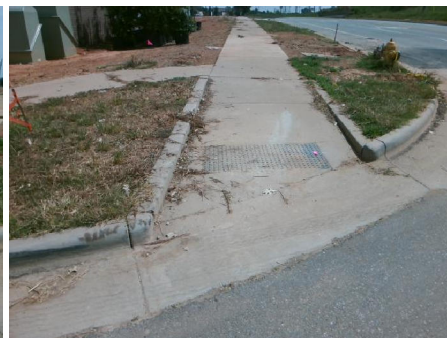
Compliance	Description	Data	Compliance	Description	Data
N/A	Ramp Length (in)	136.0	N/A	Grade Break?	N/A
Yes	Ramp Width (in)	71.0	N/A	Grade Break Slope (%)	0.0
No	Ramp Slope (%)	8.6	N/A	Grade Break XSlope (%)	0.0
Yes	Ramp XSlope (%)	1.8			
N/A	Flare Type LT	N/A	N/A	Flare Type RT	N/A
N/A	Flare Slope LT (%)	N/A	N/A	Flare Slope RT (%)	0.0
N/A	Flare Traversable LT?	N/A	N/A	Flare Traversable RT?	N/A
N/A	Landing Length (in)	0.0	N/A	DWS Provided?	N/A
N/A	Landing Width (in)	0.0	N/A	DWS Contrast?	N/A
N/A	Landing Slope (%)	0.0	N/A	DWS Length (in)	N/A
N/A	Landing X Slope (%)	0.0	N/A	DWS Full Width?	N/A
N/A	Landing Curb? (Y/N)	N/A	N/A	DWS Offset LT (in)	N/A
N/A	Shared Landing?	N/A	N/A	DWS Offset RT (in)	N/A
N/A	Gutter Ponding?	Yes	N/A	Gutter Slope (%)	N/A
N/A	Gutter Lip Ht (in)	0.0	N/A	Gutter X Slope (%)	N/A
N/A	Painted X Walk1?	No		Road Slope (%)	5.7
	X Walk 1 Direction	To SW		Road X Slope (%)	2.1
	X Walk 1 Width (in)	N/A		Clear Space?	N/A

X Walk 1 Slope (%)	5.7	N/A	Clear Space to XWalk (in)	N/A
	X Walk 1 X Slope (%)	2.1	N/A	Storm Grate/Utility Hazard?	N/A
N/A	Ramp inside XWalk1?	N/A		Storm Grate/Utility Type	
N/A	Any Obstructions?	N/A			N/A
	Obstruction Type		Yes	Surface Condition? (G/P)	Good
			N/A	Curb Slope (%)	N/A

Possible Solutions:

Remove & Replace Entire Ramp.
