Access Compliance Report Public Rights-of-Way (Curb Ramps)

Intersection ID: 7951 Main Street: BEATTIES FORD RD **Cross Street: N/A** Location: Ε ADA ID: 3183131DB41C Ramp Type: PerpDiag Initial Pass/Fail: Fail **Overall Compliance: No Severity Score:** 8.75

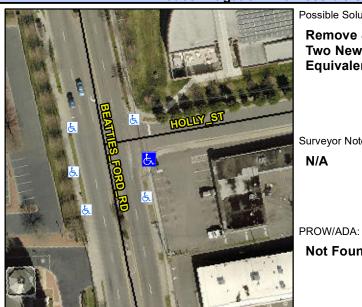
Fleid Measurements/Component Compnance						
	Compl	Compliance Description		Compliance Description		Data
	N/A	Ramp Length (in)	88.5	Yes	Ramp Slope (%)	6.6
	No	Ramp Width (in)	44.0	Yes	Ramp XSlope (%)	0.3
	N/A	Flare Type LT	N/A	N/A	Flare Type RT	N/A
	N/A	Flare Slope LT (%)	N/A	N/A	Flare Slope RT (%)	N/A
	N/A	Flare Traversable LT?	N/A	N/A	Flare Traversable RT?	N/A
	N/A	Landing Length (in)	N/A	N/A	DWS Provided?	N/A
	N/A	Landing Width (in)	N/A	N/A	DWS Contrast?	N/A
	N/A	Landing Slope (%)	N/A	N/A	DWS Length (in)	N/A
	N/A	Landing X Slope (%)	N/A	N/A	DWS Full Width?	N/A
	N/A	Landing Curb? (Y/N)	N/A	N/A	DWS Offset (in)	N/A
	N/A	Shared Landing?	N/A			
	N/A	Gutter Ponding?	N/A	N/A	Gutter Slope (%)	N/A
	N/A	Gutter Lip Ht (in)	N/A	N/A	Gutter X Slope (%)	N/A
	N/A	Painted X Walk1?	No	N/A	Painted X Walk2?	No
		X Walk 1 Direction	To N		X Walk 2 Direction	To W
	N/A	X Walk 1 Width (in)	N/A	N/A	X Walk 2 Width (in)	N/A
		X Walk 1 Slope (%)	1.7		X Walk 2 Slope (%)	2.1

X Walk 1 X Slope (%)	0.0		X Walk 2 X Slope (%)	0.5
	N/A	Ramp inside XWalk1?	N/A	N/A	Ramp inside XWalk2?	N/A
		Road Slope (%)	0.9	N/A	Clear Space?	N/A
		Road X Slope (%)	0.2	N/A	Clear Space to XWalk (in)	N/A
	N/A	Any Obstructions?	N/A	N/A	Storm Grate/Utility Hazard?	N/A
		Obstruction Type			Storm Grate/Utility Type	
			N/A			N/A
				Yes	Surface Condition? (G/P)	Good

Possible Solutions: Remove & Replace Curb Ramp With Two New Directional Ramps or Equivalent. Surveyor Notes:

> Total Cost: 3200.00
