# Access Compliance Report

## Public Rights-of-Way

### (Curb Ramps)

Intersection ID: 10021845	Main Street: BRIXHAM_HILL_AV	Cross Street: N/A	Location: SE
ADA ID: 318B15CA814F	Ramp Type: Perp	Initial Pass/Fail: Fail	Overall Compliance: No
Severity Score: 1.25			
Codes/Mitigation Info/Possible Solution		Field Measurements/Component Compliance

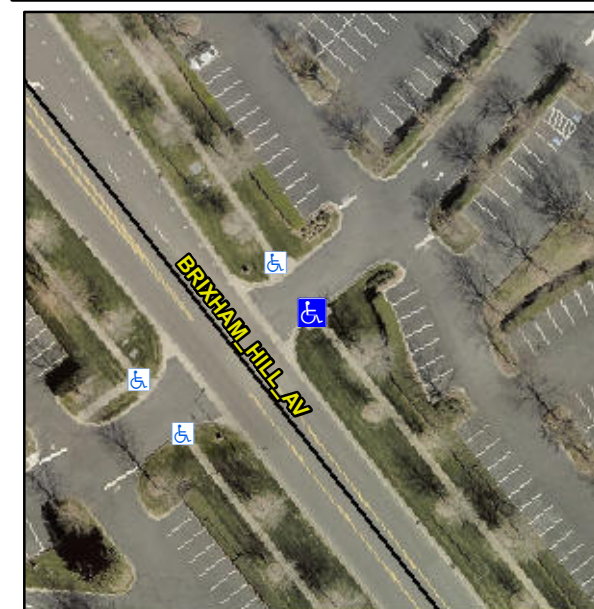
**Not Found, R304.5.3**

Compliance	Description	Data	Compliance	Description	Data
N/A	Ramp Length (in)	60.0	Yes	Ramp Slope (%)	5.8
Yes	Ramp Width (in)	49.5	No	Ramp XSlope (%)	2.9
N/A	Flare Type LT	N/A	N/A	Flare Type RT	N/A
N/A	Flare Slope LT (%)	N/A	N/A	Flare Slope RT (%)	N/A
N/A	Flare Traversable LT?	N/A	N/A	Flare Traversable RT?	N/A
N/A	Landing Length (in)	N/A	N/A	DWS Provided?	N/A
N/A	Landing Width (in)	N/A	N/A	DWS Contrast?	N/A
N/A	Landing Slope (%)	N/A	N/A	DWS Length (in)	N/A
N/A	Landing X Slope (%)	N/A	N/A	DWS Full Width?	N/A
N/A	Landing Curb? (Y/N)	N/A	N/A	DWS Offset (in)	N/A
N/A	Shared Landing?	N/A			
N/A	Gutter Ponding?	N/A	N/A	Gutter Slope (%)	N/A
N/A	Gutter Lip Ht (in)	N/A	N/A	Gutter X Slope (%)	N/A
N/A	Painted X Walk1?	No	N/A	Painted X Walk2?	N/A
	X Walk 1 Direction	To NW		X Walk 2 Direction	N/A
N/A	X Walk 1 Width (in)	N/A	N/A	X Walk 2 Width (in)	N/A
	X Walk 1 Slope (%)	2.5		X Walk 2 Slope (%)	N/A
	X Walk 1 X Slope (%)	0.8		X Walk 2 X Slope (%)	N/A

N/A	Ramp inside XWalk1?	N/A	N/A	Ramp inside XWalk2?	N/A
	Road Slope (%)	N/A	N/A	Clear Space?	N/A
	Road X Slope (%)	N/A	N/A	Clear Space to XWalk (in)	N/A
N/A	Any Obstructions?	N/A	N/A	Storm Grate/Utility Hazard?	N/A
	Obstruction Type			Storm Grate/Utility Type	
		N/A			N/A
		Yes		Surface Condition? (G/P)	Good

**Remove & Replace Entire Ramp.**

Total Cost: \$ 1850.00
