Access Compliance Report

Public Rights-of-Way (Curb Ramps)

Intersection ID: 19036	Main Street: RANDOLPH_RD	Cross Street: RANDSTONE_CT	Location: S
ADA ID: 319724E2FF64	Ramp Type: Perp	Initial Pass/Fail: Fail	Overall Compliance: No
Severity Score: 12.5			
Codes/Mitigation Info/Possible Solution		Field Measurements/Component Compliance

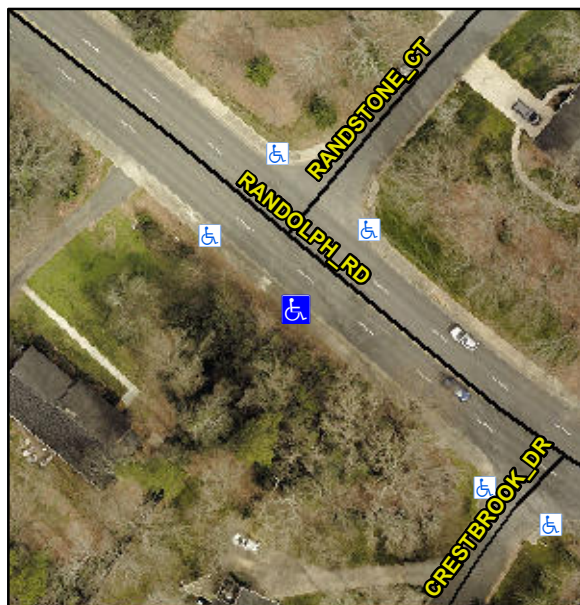
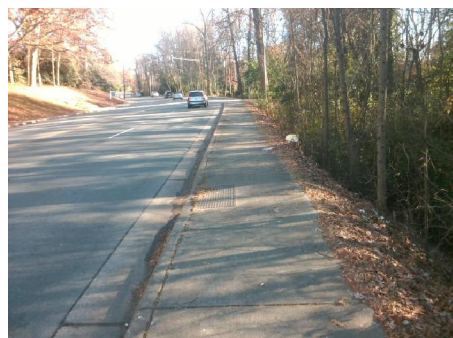
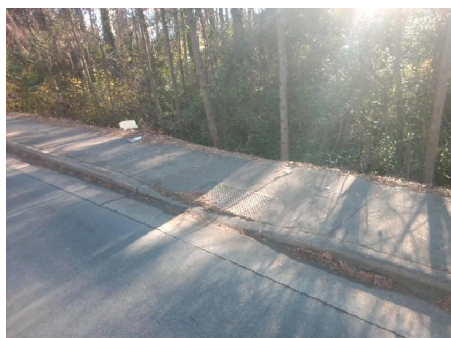
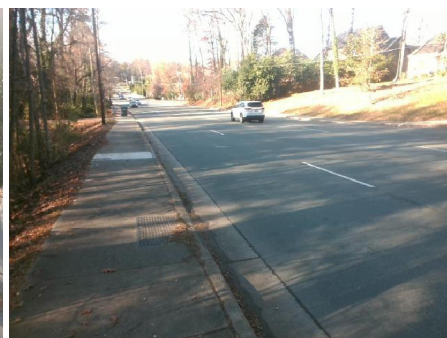
Compliance	Description	Data	Compliance	Description	Data
N/A	Ramp Length (in)	71.0	Yes	Ramp Slope (%)	6.0
Yes	Ramp Width (in)	48.0	No	Ramp XSlope (%)	5.1
N/A	Flare Type LT	N/A	N/A	Flare Type RT	N/A
N/A	Flare Slope LT (%)	N/A	N/A	Flare Slope RT (%)	N/A
N/A	Flare Traversable LT?	N/A	N/A	Flare Traversable RT?	N/A
N/A	Landing Length (in)	N/A	N/A	DWS Provided?	N/A
N/A	Landing Width (in)	N/A	N/A	DWS Contrast?	N/A
N/A	Landing Slope (%)	N/A	N/A	DWS Length (in)	N/A
N/A	Landing X Slope (%)	N/A	N/A	DWS Full Width?	N/A
N/A	Landing Curb? (Y/N)	N/A	N/A	DWS Offset (in)	N/A
N/A	Shared Landing?	N/A			
N/A	Gutter Ponding?	N/A	N/A	Gutter Slope (%)	N/A
N/A	Gutter Lip Ht (in)	N/A	N/A	Gutter X Slope (%)	N/A
N/A	Painted X Walk1?	No	N/A	Painted X Walk2?	N/A
	X Walk 1 Direction	To NE		X Walk 2 Direction	N/A
N/A	X Walk 1 Width (in)	N/A	N/A	X Walk 2 Width (in)	N/A
	X Walk 1 Slope (%)	2.4		X Walk 2 Slope (%)	N/A
	X Walk 1 X Slope (%)	3.6		X Walk 2 X Slope (%)	N/A

N/A	Ramp inside XWalk1?	N/A	N/A	Ramp inside XWalk2?	N/A
	Road Slope (%)	N/A	N/A	Clear Space?	N/A
	Road X Slope (%)	N/A	N/A	Clear Space to XWalk (in)	N/A
N/A	Any Obstructions?	N/A	N/A	Storm Grate/Utility Hazard?	N/A
	Obstruction Type			Storm Grate/Utility Type	
		N/A			N/A
			Yes	Surface Condition? (G/P)	Good

Possible Solutions:

Remove & Replace Entire Ramp.
