Access Compliance Report

Public Rights-of-Way

(Curb Ramps)

Intersection ID: 14355	Main Street: OAKMONT_AV	Cross Street: PINECREST_AV	Location: SE
ADA ID: 31A808408ECD	Ramp Type: Perp	Initial Pass/Fail: Fail	Overall Compliance: No
		Severity Score: 22.5

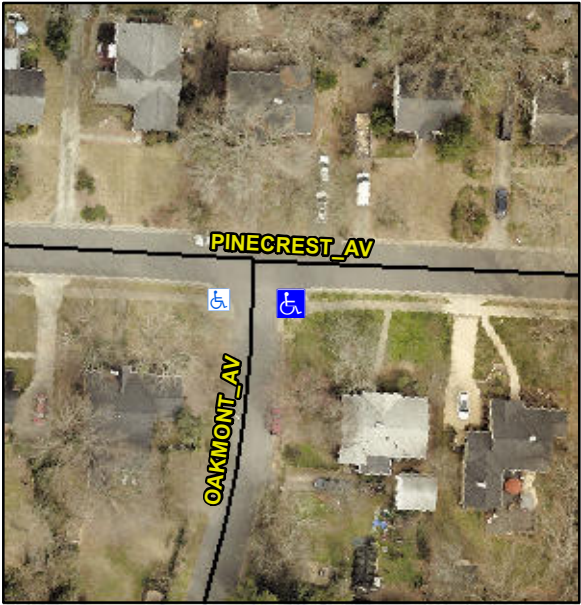
Possible Solutions:		Compliance	Description	Data
	Remove & Replace Entire Ramp.		No	Ramp Length (in)	44.0
			No	Ramp Width (in)	43.0
			N/A	Flare Type LT	N/A
			N/A	Flare Slope LT (%)	N/A
			N/A	Flare Traversable LT?	N/A
			N/A	Landing Length (in)	N/A
			N/A	Landing Width (in)	N/A
			N/A	Landing Slope (%)	N/A
			N/A	Landing X Slope (%)	N/A
<p>Surveyor Notes:</p> <p>N/A</p> <p>PROW/ADA:</p> <p>Not Found, R304.5.1, R304.2.2, R304.5.3</p>			N/A	Flare Type RT	N/A
			N/A	Flare Slope RT (%)	N/A
			N/A	Flare Traversable RT?	N/A
			N/A	DWS Provided?	N/A
			N/A	DWS Contrast?	N/A
			N/A	DWS Length (in)	N/A
			N/A	DWS Full Width?	N/A
			N/A	DWS Offset (in)	N/A
			N/A	Gutter Ponding?	N/A
			N/A	Gutter Lip Ht (in)	N/A
<p>Total Cost:</p> <p>\$ 1850.00</p>			No	Painted X Walk1?	N/A
			To W	X Walk 1 Direction	N/A
			N/A	X Walk 1 Width (in)	N/A

1.0	X Walk 1 Slope (%)	N/A
			2.8	X Walk 1 X Slope (%)	N/A
			N/A	Ramp inside XWalk1?	N/A
			N/A	Road Slope (%)	N/A
			N/A	Road X Slope (%)	N/A
			N/A	Any Obstructions?	N/A
			N/A	Obstruction Type	N/A
			N/A	Clear Space?	N/A
			N/A	Clear Space to XWalk (in)	N/A
			N/A	Storm Grate/Utility Hazard?	N/A
			N/A	Storm Grate/Utility Type	N/A
			Yes	Surface Condition? (G/P)	Good
