Access Compliance Report

Public Rights-of-Way

(Curb Ramps)

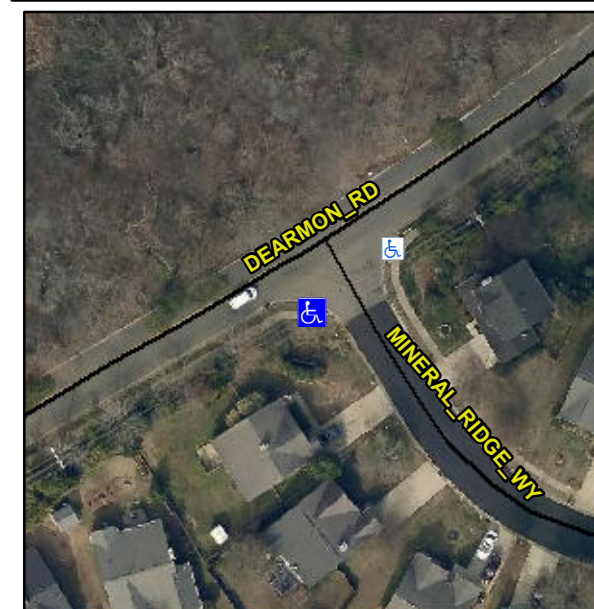
Intersection ID: 3088	Main Street: DEARMON_RD	Cross Street: MINERAL_RIDGE_WY	Location: S
ADA ID: 31BF00F01588	Ramp Type: Perp	Initial Pass/Fail: Fail	Overall Compliance: No
Severity Score: 58.75			
Codes/Mitigation Info/Possible Solution		Field Measurements/Component Compliance

Compliance	Description	Data	Compliance	Description	Data
N/A	Ramp Length (in)	97.5	No	Ramp Slope (%)	18.4
No	Ramp Width (in)	36.5	No	Ramp XSlope (%)	9.5
N/A	Flare Type LT	N/A	N/A	Flare Type RT	N/A
N/A	Flare Slope LT (%)	N/A	N/A	Flare Slope RT (%)	N/A
N/A	Flare Traversable LT?	N/A	N/A	Flare Traversable RT?	N/A
N/A	Landing Length (in)	N/A	N/A	DWS Provided?	N/A
N/A	Landing Width (in)	N/A	N/A	DWS Contrast?	N/A
N/A	Landing Slope (%)	N/A	N/A	DWS Length (in)	N/A
N/A	Landing X Slope (%)	N/A	N/A	DWS Full Width?	N/A
N/A	Landing Curb? (Y/N)	N/A	N/A	DWS Offset (in)	N/A
N/A	Shared Landing?	N/A			
N/A	Gutter Ponding?	N/A	N/A	Gutter Slope (%)	N/A
N/A	Gutter Lip Ht (in)	N/A	N/A	Gutter X Slope (%)	N/A
N/A	Painted X Walk1?	No	N/A	Painted X Walk2?	N/A
	X Walk 1 Direction	To NE		X Walk 2 Direction	N/A
N/A	X Walk 1 Width (in)	N/A	N/A	X Walk 2 Width (in)	N/A
	X Walk 1 Slope (%)	2.4		X Walk 2 Slope (%)	N/A
	X Walk 1 X Slope (%)	9.8		X Walk 2 X Slope (%)	N/A

Possible Solutions:

Remove & Replace Entire Ramp.

R304.5.1, R304.2.2, R304.5.3
