Access Compliance Report

Public Rights-of-Way

(Curb Ramps)

Intersection ID: 47851	Main Street: CACTUS_VALLEY_RD	Cross Street: SERAPE_RD	Location: SE
ADA ID: 31C030307FB5	Ramp Type: Perp	Initial Pass/Fail: Fail	Overall Compliance: No
Severity Score: 8.75			
Codes/Mitigation Info/Possible Solution		Field Measurements/Component Compliance

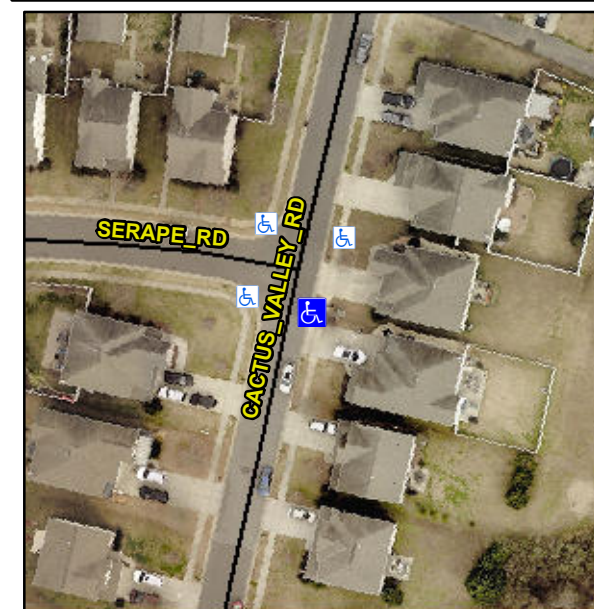
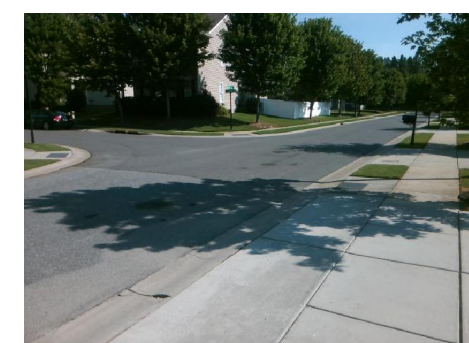
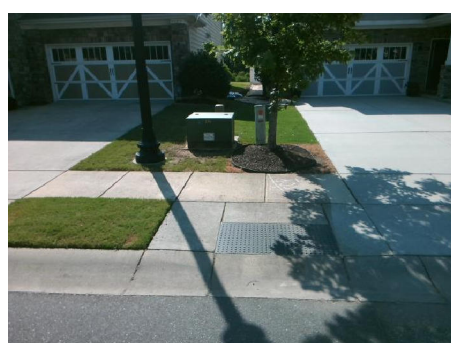
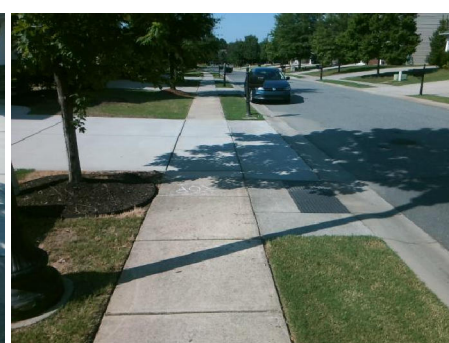
Not Found, R304.5.1

Compliance	Description	Data	Compliance	Description	Data
N/A	Ramp Length (in)	47.0	Yes	Ramp Slope (%)	6.0
No	Ramp Width (in)	47.0	Yes	Ramp XSlope (%)	1.0
N/A	Flare Type LT	N/A	N/A	Flare Type RT	N/A
N/A	Flare Slope LT (%)	N/A	N/A	Flare Slope RT (%)	N/A
N/A	Flare Traversable LT?	N/A	N/A	Flare Traversable RT?	N/A
N/A	Landing Length (in)	N/A	N/A	DWS Provided?	N/A
N/A	Landing Width (in)	N/A	N/A	DWS Contrast?	N/A
N/A	Landing Slope (%)	N/A	N/A	DWS Length (in)	N/A
N/A	Landing X Slope (%)	N/A	N/A	DWS Full Width?	N/A
N/A	Landing Curb? (Y/N)	N/A	N/A	DWS Offset (in)	N/A
N/A	Shared Landing?	N/A			
N/A	Gutter Ponding?	N/A	N/A	Gutter Slope (%)	N/A
N/A	Gutter Lip Ht (in)	N/A	N/A	Gutter X Slope (%)	N/A
N/A	Painted X Walk1?	No	N/A	Painted X Walk2?	N/A
	X Walk 1 Direction	To NW		X Walk 2 Direction	N/A
N/A	X Walk 1 Width (in)	N/A	N/A	X Walk 2 Width (in)	N/A
	X Walk 1 Slope (%)	1.4		X Walk 2 Slope (%)	N/A
	X Walk 1 X Slope (%)	0.8		X Walk 2 X Slope (%)	N/A

N/A	Ramp inside XWalk1?	N/A	N/A	Ramp inside XWalk2?	N/A
	Road Slope (%)	N/A	N/A	Clear Space?	N/A
	Road X Slope (%)	N/A	N/A	Clear Space to XWalk (in)	N/A
N/A	Any Obstructions?	N/A	N/A	Storm Grate/Utility Hazard?	N/A
	Obstruction Type			Storm Grate/Utility Type	
		N/A			N/A
			Yes	Surface Condition? (G/P)	Good

Remove & Replace Entire Ramp.
