# Access Compliance Report

## Public Rights-of-Way

### (Curb Ramps)

| Intersection ID: 45499 | Main Street: BUGGY_HORSE_RD | Cross Street: GRASSY_CROPS_RD | Location: E |

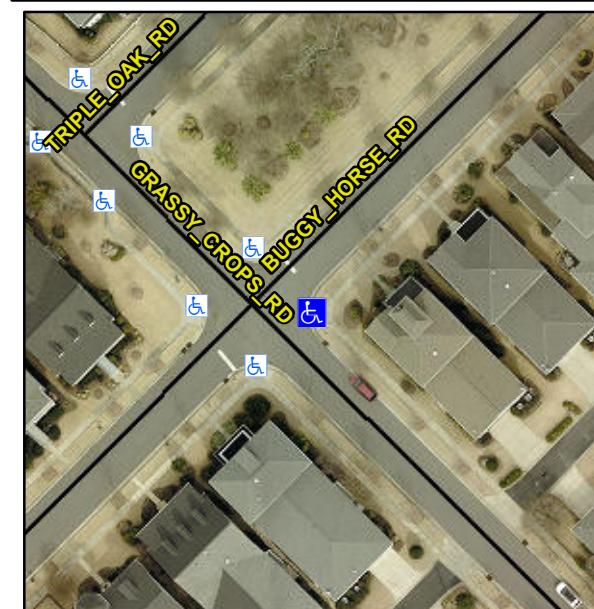
| ADA ID: 31CCF7958E37 | Ramp Type: Combination1Diag | Initial Pass/Fail: Fail | Overall Compliance: No |

Surveyor Notes:

**RT RP < 5%**

PROW/ADA:

**Not Found, R304.5.1, R304.2.2, R304.5.3**

| Compliance | Description | Data | Compliance | Description | Data |
|---|---|---|---|---|---|
| Yes | Ramp Slope LT (%) | 5.5 | Yes | Ramp Slope RT (%) | 3.4 |
| No | Ramp XSlope LT (%) | 3.3 | No | Ramp XSlope RT (%) | 2.8 |
| N/A | Ramp Length (in) | 72.0 | No | Ramp Slope (%) | 11.6 |
| No | Ramp Width (in) | 32.0 | No | Ramp XSlope (%) | 3.8 |

Possible Solutions:

**Remove & Replace Curb Ramp With Two New Directional Ramps or Equivalent.**

Total Cost: \$ 3200.00
