Access Compliance Report

Public Rights-of-Way

(Curb Ramps)

Intersection ID: 21348	Main Street: CARMEL_RD	Cross Street: SHARON_VIEW_RD	Location: SW
ADA ID: 31E05E4A671D	Ramp Type: PerpDiag	Initial Pass/Fail: Fail	Overall Compliance: No
		Severity Score: 8.75

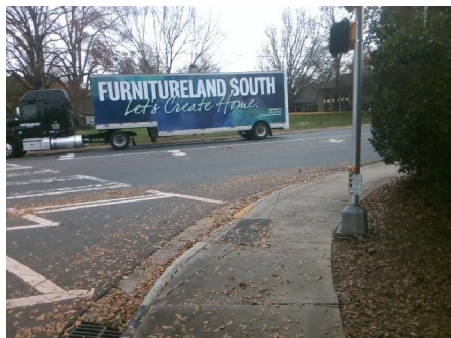
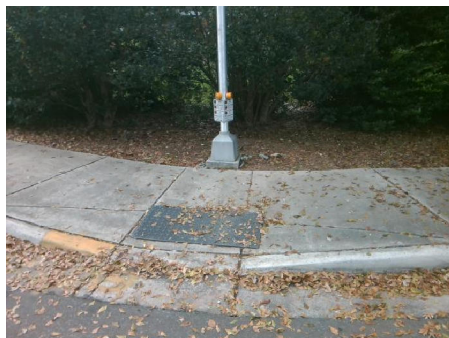
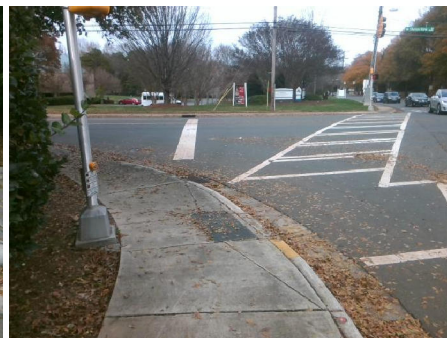
Not Found, R304.5.1

Compliance	Description	Data	Compliance	Description	Data
N/A	Ramp Length (in)	71.0	Yes	Ramp Slope (%)	7.4
No	Ramp Width (in)	37.0	Yes	Ramp XSlope (%)	1.2
N/A	Flare Type LT	N/A	N/A	Flare Type RT	N/A
N/A	Flare Slope LT (%)	N/A	N/A	Flare Slope RT (%)	N/A
N/A	Flare Traversable LT?	N/A	N/A	Flare Traversable RT?	N/A
N/A	Landing Length (in)	N/A	N/A	DWS Provided?	N/A
N/A	Landing Width (in)	N/A	N/A	DWS Contrast?	N/A
N/A	Landing Slope (%)	N/A	N/A	DWS Length (in)	N/A
N/A	Landing X Slope (%)	N/A	N/A	DWS Full Width?	N/A
N/A	Landing Curb? (Y/N)	N/A	N/A	DWS Offset (in)	N/A
N/A	Shared Landing?	N/A			
N/A	Gutter Ponding?	N/A	N/A	Gutter Slope (%)	N/A
N/A	Gutter Lip Ht (in)	N/A	N/A	Gutter X Slope (%)	N/A
N/A	Painted X Walk1?	Yes	N/A	Painted X Walk2?	Yes
	X Walk 1 Direction	To E		X Walk 2 Direction	To NE
N/A	X Walk 1 Width (in)	105.0	N/A	X Walk 2 Width (in)	113.0
	X Walk 1 Slope (%)	3.2		X Walk 2 Slope (%)	4.5
	X Walk 1 X Slope (%)	0.0		X Walk 2 X Slope (%)	3.7

N/A	Ramp inside XWalk1?	Yes	N/A	Ramp inside XWalk2?	Yes
	Road Slope (%)	1.3	N/A	Clear Space?	N/A
	Road X Slope (%)	3.2	N/A	Clear Space to XWalk (in)	N/A
N/A	Any Obstructions?	N/A	N/A	Storm Grate/Utility Hazard?	N/A
	Obstruction Type			Storm Grate/Utility Type	
		N/A			N/A
		Yes		Surface Condition? (G/P)	Good

Remove & Replace Curb Ramp With Two New Directional Ramps or Equivalent.
