Access Compliance Report

Public Rights-of-Way

(Curb Ramps)

Intersection ID: 2765	Main Street: BEAUVISTA_DR	Cross Street: HICKORY_COVE_LN	Location: SW
ADA ID: 31F7110EF1D9	Ramp Type: PerpDiag	Initial Pass/Fail: Fail	Overall Compliance: No
Severity Score: 21.25			
Codes/Mitigation Info/Possible Solution		Field Measurements/Component Compliance

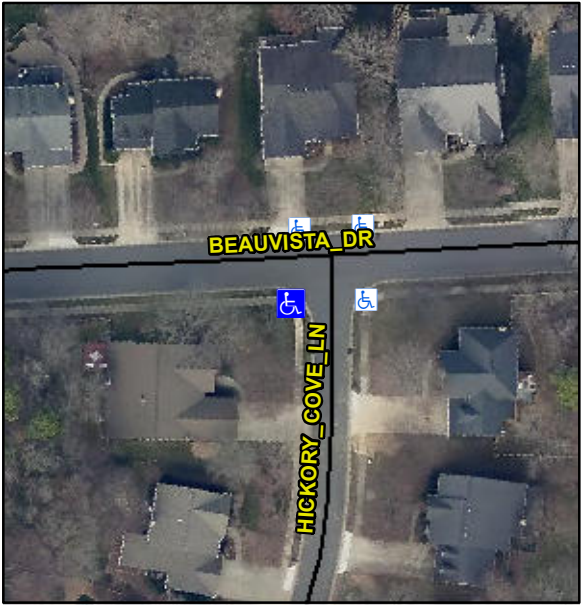
N/A	Gutter Ponding?	N/A	N/A	Gutter Slope (%)	N/A
		N/A	Gutter Lip Ht (in)	N/A	N/A	Gutter X Slope (%)	N/A
		N/A	Painted X Walk1?	No	N/A	Painted X Walk2?	No
			X Walk 1 Direction	To E		X Walk 2 Direction	To N
		N/A	X Walk 1 Width (in)	N/A	N/A	X Walk 2 Width (in)	N/A
			X Walk 1 Slope (%)	6.5		X Walk 2 Slope (%)	6.1
			X Walk 1 X Slope (%)	3.8		X Walk 2 X Slope (%)	8.0
		N/A	Ramp inside XWalk1?	N/A	N/A	Ramp inside XWalk2?	N/A
			Road Slope (%)	6.6	N/A	Clear Space?	N/A
			Road X Slope (%)	3.6	N/A	Clear Space to XWalk (in)	N/A
		N/A	Any Obstructions?	N/A	N/A	Storm Grate/Utility Hazard?	N/A
			Obstruction Type			Storm Grate/Utility Type	
					N/A		N/A
					Yes	Surface Condition? (G/P)	Good
Total Cost:		\$ 3200.00

Possible Solutions:						
	Remove & Replace Curb Ramp With Two New Directional Ramps or Equivalent.						
	Surveyor Notes:						
	N/A						
	PROW/ADA:						
	Not Found, R304.5.1, R304.5.3						
Street 1 Name	HICKORY COVE LN	Compliance	Description	Data	Compliance	Description	Data
Stop Condition-Street 2	StopSign	N/A	Ramp Length (in)	49.0	Yes	Ramp Slope (%)	5.9
Street 2 Name	BEAUVISTA DR	No	Ramp Width (in)	39.0	No	Ramp XSlope (%)	6.8
Stop Condition-Street 1	None	N/A	Flare Type LT	N/A	N/A	Flare Type RT	N/A
		N/A	Flare Slope LT (%)	N/A	N/A	Flare Slope RT (%)	N/A
		N/A	Flare Traversable LT?	N/A	N/A	Flare Traversable RT?	N/A
		N/A	Landing Length (in)	N/A	N/A	DWS Provided?	N/A
		N/A	Landing Width (in)	N/A	N/A	DWS Contrast?	N/A
		N/A	Landing Slope (%)	N/A	N/A	DWS Length (in)	N/A
		N/A	Landing X Slope (%)	N/A	N/A	DWS Full Width?	N/A
		N/A	Landing Curb? (Y/N)	N/A	N/A	DWS Offset (in)	N/A
		N/A	Shared Landing?	N/A
