Access Compliance Report

Public Rights-of-Way

(Curb Ramps)

Intersection ID: 29144	Main Street: DEATON_HILL_DR	Cross Street: HUNTERS_CREEK_CT	Location: NW
ADA ID: 31F84B9C0E0D	Ramp Type: PerpDiag	Initial Pass/Fail: Fail	Overall Compliance: No
Severity Score: 22.5			
Codes/Mitigation Info/Possible Solution		Field Measurements/Component Compliance

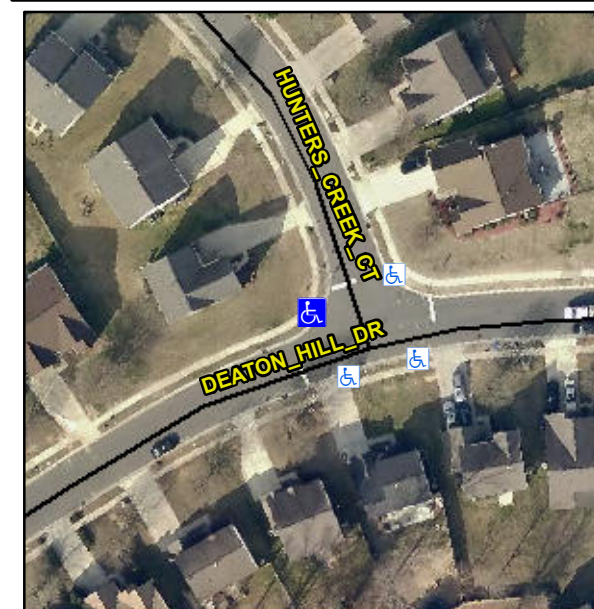
Compliance	Description	Data	Compliance	Description	Data
N/A	Ramp Length (in)	48.0	No	Ramp Slope (%)	8.4
No	Ramp Width (in)	47.5	No	Ramp XSlope (%)	4.1
N/A	Flare Type LT	N/A	N/A	Flare Type RT	N/A
N/A	Flare Slope LT (%)	N/A	N/A	Flare Slope RT (%)	N/A
N/A	Flare Traversable LT?	N/A	N/A	Flare Traversable RT?	N/A
N/A	Landing Length (in)	N/A	N/A	DWS Provided?	N/A
N/A	Landing Width (in)	N/A	N/A	DWS Contrast?	N/A
N/A	Landing Slope (%)	N/A	N/A	DWS Length (in)	N/A
N/A	Landing X Slope (%)	N/A	N/A	DWS Full Width?	N/A
N/A	Landing Curb? (Y/N)	N/A	N/A	DWS Offset (in)	N/A
N/A	Shared Landing?	N/A			
N/A	Gutter Ponding?	N/A	N/A	Gutter Slope (%)	N/A
N/A	Gutter Lip Ht (in)	N/A	N/A	Gutter X Slope (%)	N/A
N/A	Painted X Walk1?	No	N/A	Painted X Walk2?	No
	X Walk 1 Direction	To S		X Walk 2 Direction	To E
N/A	X Walk 1 Width (in)	N/A	N/A	X Walk 2 Width (in)	N/A
	X Walk 1 Slope (%)	5.3		X Walk 2 Slope (%)	0.9
	X Walk 1 X Slope (%)	1.8		X Walk 2 X Slope (%)	4.7

N/A	Ramp inside XWalk1?	N/A	N/A	Ramp inside XWalk2?	N/A
	Road Slope (%)	3.3	N/A	Clear Space?	N/A
	Road X Slope (%)	3.9	N/A	Clear Space to XWalk (in)	N/A
N/A	Any Obstructions?	N/A	N/A	Storm Grate/Utility Hazard?	N/A
	Obstruction Type			Storm Grate/Utility Type	
		N/A			N/A
			Yes	Surface Condition? (G/P)	Good

Remove & Replace Curb Ramp With Two New Directional Ramps or Equivalent.

R304.5.1, R304.2.2, R304.5.3
