| Intersection ID: 6039 | Main Street: DELLINGER_DR | Cross Street: MILHAVEN_LN | Location: | SW |
| ADA ID: 31FA27392AC6 | Ramp Type: BlendTrans1 | Initial Pass/Fail: Fail | Overall Compliance: No | Severity Score: 1.25 |

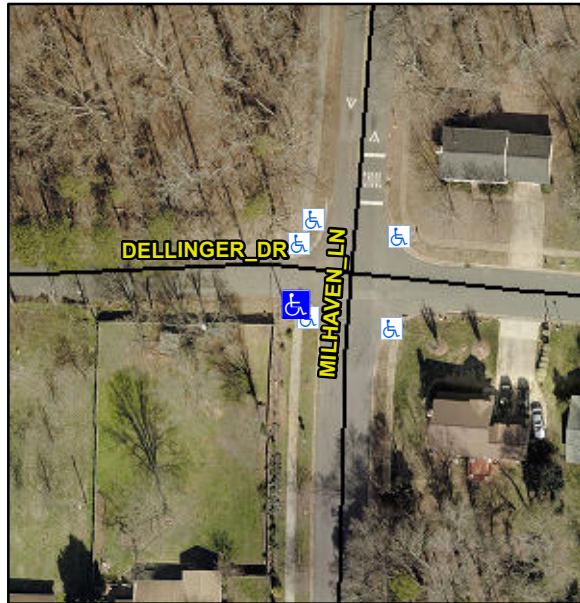
**Not Found, R304.5.3**

| Compliance | Description | Data | Compliance | Description | Data |
|---|---|---|---|---|---|
| Yes | Ramp Width (in) | 60.0 | No | BlendTrans XSlope (%) | 4.3 |
| | | | No | Curb Slope (%) | 7.0 |

**Remove & Replace Curb Ramp With Two New Directional Ramps or Equivalent.**
