Access Compliance Report

Public Rights-of-Way

(Curb Ramps)

| Intersection ID: 30270 | Main Street: ATLANTIQUE_CT | Cross Street: OLD_IRONSIDE_DR | Location: NE |

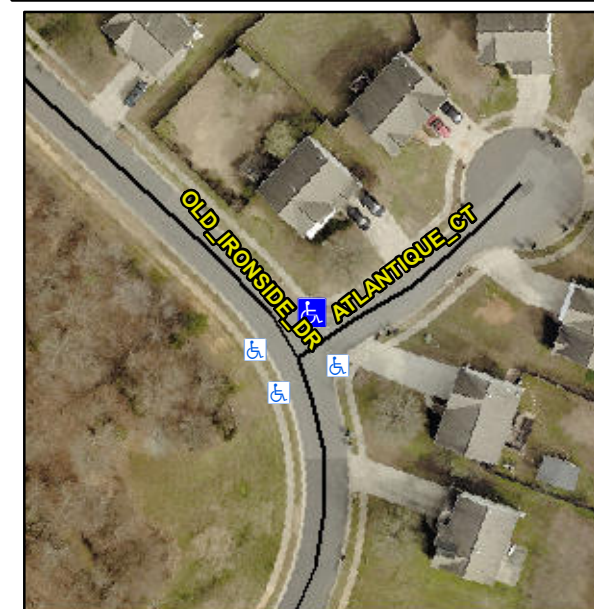
| ADA ID: 31FC5B2A91CC | Ramp Type: PerpDiag | Initial Pass/Fail: Fail | Overall Compliance: No |
| Severity Score: 8.75 | | | |

R304.5.1

| Compliance | Description | Data | Compliance | Description | Data |
|---|---|---|---|---|---|
| No | Ramp Width (in) | 46.5 | Yes | Ramp XSlope (%) | 1.4 |

Remove & Replace Curb Ramp With Two New Directional Ramps or Equivalent.
