# Access Compliance Report

## Public Rights-of-Way

### (Curb Ramps)

| Intersection ID: 8439 | Main Street: TILLMAN_RD | Cross Street: WELLING_AV | Location: W |

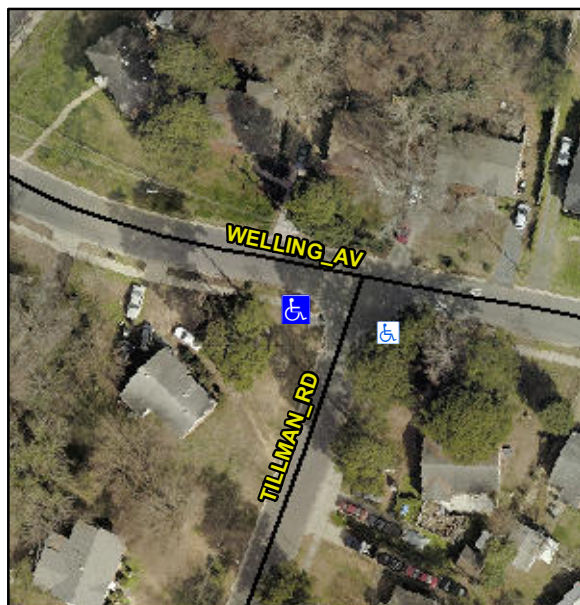
| ADA ID: 3204FC3CE1EA | Ramp Type: Perp | Initial Pass/Fail: Fail | Overall Compliance: No |
| Severity Score: 10 | | | |

**Not Found, R304.5.1, R304.5.3**

| Compliance | Description | Data | Compliance | Description | Data |
|---|---|---|---|---|---|
| N/A | Ramp Length (in) | 50.5 | Yes | Ramp Slope (%) | 7.0 |
| No | Ramp Width (in) | 47.0 | No | Ramp XSlope (%) | 3.5 |

**Remove & Replace Entire Ramp.**

Total Cost: \$ 1850.00
