# Access Compliance Report

## Public Rights-of-Way

### (Curb Ramps)

Intersection ID: 11003	Main Street: CAMP_GREENE_ST	Cross Street: RINGWOOD_ST	Location: NW
ADA ID: 320C2B24D7F7	Ramp Type: BlendTrans1	Initial Pass/Fail: Fail	Overall Compliance: No
		Severity Score: 17.5

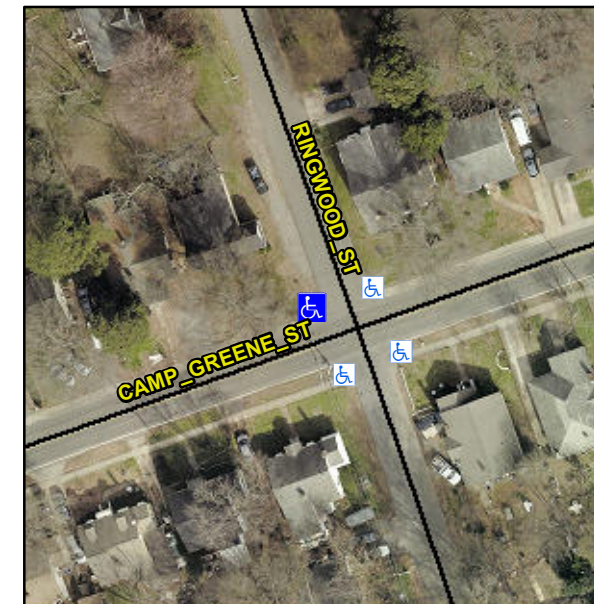
Compliance	Description	Data	Compliance	Description	Data
N/A	Ramp Length (in)	51.0	Yes	BlendTrans Slope (%)	2.2
No	Ramp Width (in)	32.0	Yes	BlendTrans XSlope (%)	0.0
N/A	Flare Type LT	N/A	N/A	Flare Type RT	N/A
N/A	Flare Slope LT (%)	N/A	N/A	Flare Slope RT (%)	N/A
N/A	Flare Traversable LT?	N/A	N/A	Flare Traversable RT?	N/A
N/A	Landing Length (in)	N/A	N/A	DWS Provided?	N/A
N/A	Landing Width (in)	N/A	N/A	DWS Contrast?	N/A
N/A	Landing Slope (%)	N/A	N/A	DWS Length (in)	N/A
N/A	Landing X Slope (%)	N/A	N/A	DWS Full Width?	N/A
N/A	Landing Curb? (Y/N)	N/A	N/A	DWS Offset (in)	N/A
N/A	Shared Landing?	N/A			
N/A	Gutter Ponding?	N/A	N/A	Gutter Slope (%)	N/A
N/A	Gutter Lip Ht (in)	0.5	N/A	Gutter X Slope (%)	N/A
N/A	Painted X Walk1?	No	N/A	Painted X Walk2?	No
	X Walk 1 Direction	To S		X Walk 2 Direction	To E
	X Walk 1 Width (in)	N/A		X Walk 2 Width (in)	N/A
	X Walk 1 Slope (%)	5.3		X Walk 2 Slope (%)	3.6
	X Walk 1 X Slope (%)	3.3		X Walk 2 X Slope (%)	1.4

N/A	Ramp inside XWalk1?	N/A	N/A	Ramp inside XWalk2?	N/A
	Road Slope (%)	1.0		Clear Space?	N/A
	Road X Slope (%)	3.9	N/A	Clear Space to XWalk (in)	N/A
N/A	Any Obstructions?	N/A	N/A	Storm Grate/Utility Hazard?	N/A
	Obstruction Type			Storm Grate/Utility Type	
		N/A			N/A
			Yes	Surface Condition? (G/P)	Good
			N/A	Curb Slope (%)	0.1

**Remove & Replace Curb Ramp With Two New Directional Ramps or Equivalent.**

**R304.5.1**

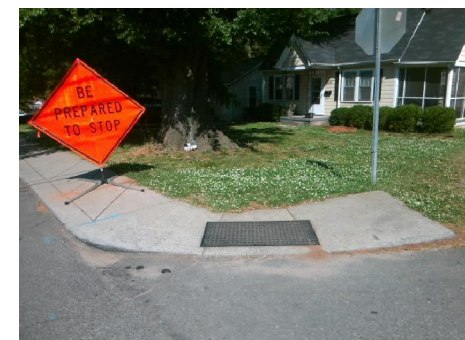
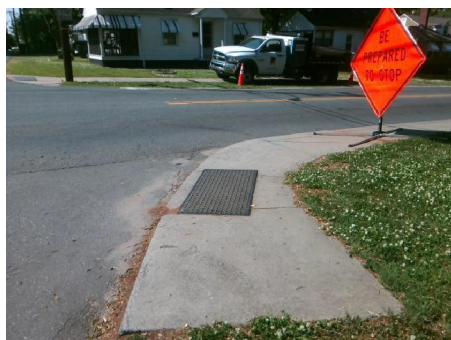
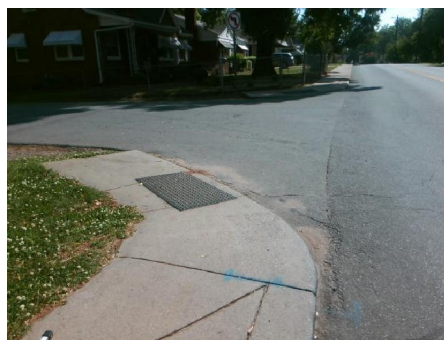
Street 1 Name **CAMP GREENE ST**  
 Stop Condition-Street 1 **None**  
 Street 2 Name **RINGWOOD ST**  
 Stop Condition-Street 2 **StopSign**
