# Access Compliance Report

## Public Rights-of-Way

### (Curb Ramps)

Intersection ID: 10037286	Main Street: SARDIS_RD_NORTH	Cross Street: N/A	Location: SW
ADA ID: 321454E93A52	Ramp Type: Para	Initial Pass/Fail: Fail	Overall Compliance: No
		Severity Score: 1.25

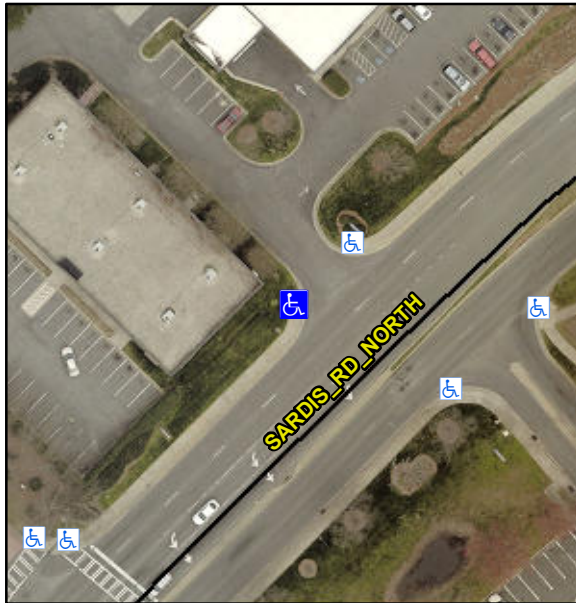
**RT RP < 5%**

**Not Found, R304.5.3**

Compliance	Description	Data	Compliance	Description	Data
N/A	Ramp Length LT (in)	57.0	N/A	Ramp Length RT (in)	76.0
Yes	Ramp Width LT (in)	72.0	Yes	Ramp Width RT (in)	70.0
Yes	Ramp Slope LT (%)	5.5	Yes	Ramp Slope RT (%)	1.7
Yes	Ramp XSlope LT (%)	1.2	No	Ramp XSlope RT (%)	3.2
N/A	Landing Length (in)	N/A	N/A	DWS Provided?	N/A
N/A	Landing Width (in)	N/A	N/A	DWS Contrast?	N/A
N/A	Landing Slope (%)	N/A	N/A	DWS Length (in)	N/A
N/A	Landing X Slope (%)	N/A	N/A	DWS Full Width?	N/A
N/A	Landing Curb? (Y/N)	N/A	N/A	DWS Offset (in)	N/A
N/A	Shared Landing?	N/A			
N/A	Gutter Ponding?	N/A	N/A	Gutter Slope (%)	N/A
N/A	Gutter Lip Ht (in)	N/A	N/A	Gutter X Slope (%)	N/A
N/A	Painted X Walk1?	No	N/A	Painted X Walk2?	N/A
	X Walk 1 Direction	To NE		X Walk 2 Direction	N/A
N/A	X Walk 1 Width (in)	N/A	N/A	X Walk 2 Width (in)	N/A
	X Walk 1 Slope (%)	1.6		X Walk 2 Slope (%)	N/A
	X Walk 1 X Slope (%)	4.0		X Walk 2 X Slope (%)	N/A
N/A	Ramp inside XWalk1?	N/A	N/A	Ramp inside XWalk2?	N/A

Road Slope (%)	N/A	N/A	Clear Space?	N/A
	Road X Slope (%)	N/A	N/A	Clear Space to XWalk (in)	N/A
N/A	Any Obstructions?	N/A	N/A	Storm Grate/Utility Hazard?	N/A
	Obstruction Type			Storm Grate/Utility Type	
		N/A			N/A
			Yes	Surface Condition? (G/P)	Good
			Replace	Curb Slope (%)	11.5

Possible Solutions:

**Remove & Replace Entire Ramp.**
