# Access Compliance Report

## Public Rights-of-Way

### (Curb Ramps)

Intersection ID: 27440	Main Street: BALLANTYNE COMMONS PY	Cross Street: DOWINGTON DR	Location: SE
ADA ID: 3229948305C6	Ramp Type: Perp	Initial Pass/Fail: Fail	Overall Compliance: No
		Severity Score: 8.75

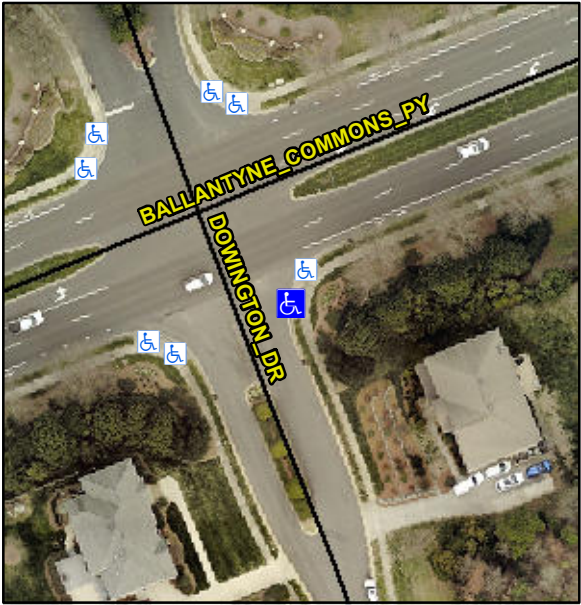
Codes/Mitigation Info/Possible Solution		Field Measurements/Component Compliance

Compliance	Description	Data	Compliance	Description	Data
N/A	Ramp Length (in)	108.0	Yes	Ramp Slope (%)	5.2
No	Ramp Width (in)	37.0	Yes	Ramp XSlope (%)	0.0
N/A	Flare Type LT	N/A	N/A	Flare Type RT	N/A
N/A	Flare Slope LT (%)	N/A	N/A	Flare Slope RT (%)	N/A
N/A	Flare Traversable LT?	N/A	N/A	Flare Traversable RT?	N/A
N/A	Landing Length (in)	N/A	N/A	DWS Provided?	N/A
N/A	Landing Width (in)	N/A	N/A	DWS Contrast?	N/A
N/A	Landing Slope (%)	N/A	N/A	DWS Length (in)	N/A
N/A	Landing X Slope (%)	N/A	N/A	DWS Full Width?	N/A
N/A	Landing Curb? (Y/N)	N/A	N/A	DWS Offset (in)	N/A
N/A	Shared Landing?	N/A			
N/A	Gutter Ponding?	N/A	N/A	Gutter Slope (%)	N/A
N/A	Gutter Lip Ht (in)	N/A	N/A	Gutter X Slope (%)	N/A
N/A	Painted X Walk1?	No	N/A	Painted X Walk2?	N/A
	X Walk 1 Direction	To W		X Walk 2 Direction	N/A
N/A	X Walk 1 Width (in)	N/A	N/A	X Walk 2 Width (in)	N/A
	X Walk 1 Slope (%)	0.5		X Walk 2 Slope (%)	N/A
	X Walk 1 X Slope (%)	2.2		X Walk 2 X Slope (%)	N/A

N/A	Ramp inside XWalk1?	N/A	N/A	Ramp inside XWalk2?	N/A
	Road Slope (%)	N/A	N/A	Clear Space?	N/A
	Road X Slope (%)	N/A	N/A	Clear Space to XWalk (in)	N/A
N/A	Any Obstructions?	N/A	N/A	Storm Grate/Utility Hazard?	N/A
	Obstruction Type			Storm Grate/Utility Type	
		N/A			N/A
			Yes	Surface Condition? (G/P)	Good

Possible Solutions:				
	Remove & Replace Entire Ramp.				
	Surveyor Notes:				
	N/A				
	PROW/ADA:				
	Not Found, R304.5.1				
Street 1 Name	DOWINGTON DR				
Stop Condition-Street 2	StopSign				
Street 2 Name	N/A				
Stop Condition-Street 1	N/A				
Total Cost:		\$	1850.00
