# Access Compliance Report

## Public Rights-of-Way

### (Curb Ramps)

Intersection ID: 21797	Main Street: GALLERIA_BV	Cross Street: MONROE_RD	Location: NE
ADA ID: 3234B6394CC1	Ramp Type: Perp	Initial Pass/Fail: Fail	Overall Compliance: No
			Severity Score: 48.75
Codes/Mitigation Info/Possible Solution		Field Measurements/Component Compliance

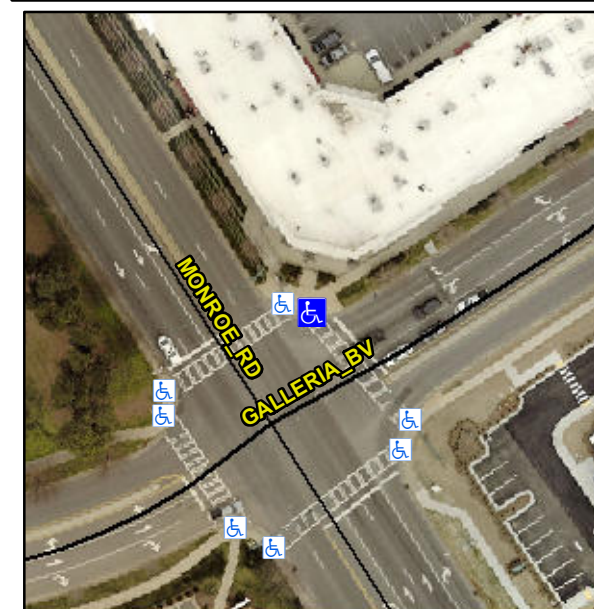
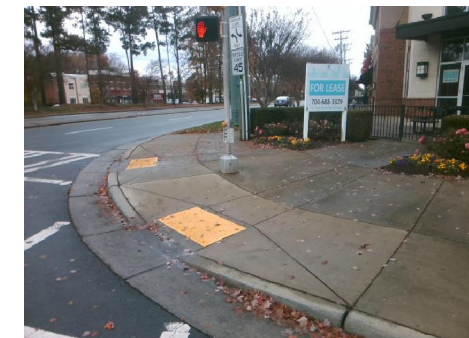
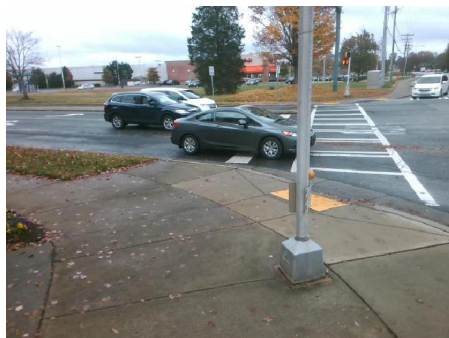
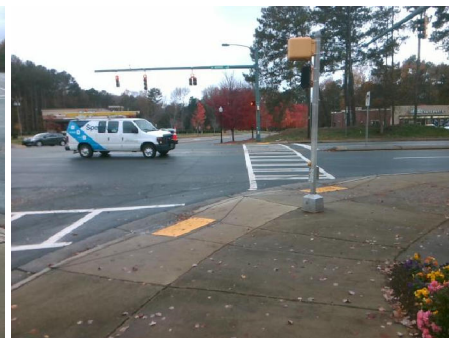
Compliance	Description	Data	Compliance	Description	Data
N/A	Ramp Length (in)	170.0	No	Ramp Slope (%)	8.5
No	Ramp Width (in)	25.0	No	Ramp XSlope (%)	2.2
N/A	Flare Type LT	N/A	N/A	Flare Type RT	N/A
N/A	Flare Slope LT (%)	N/A	N/A	Flare Slope RT (%)	N/A
N/A	Flare Traversable LT?	N/A	N/A	Flare Traversable RT?	N/A
N/A	Landing Length (in)	N/A	N/A	DWS Provided?	N/A
N/A	Landing Width (in)	N/A	N/A	DWS Contrast?	N/A
N/A	Landing Slope (%)	N/A	N/A	DWS Length (in)	N/A
N/A	Landing X Slope (%)	N/A	N/A	DWS Full Width?	N/A
N/A	Landing Curb? (Y/N)	N/A	N/A	DWS Offset (in)	N/A
N/A	Shared Landing?	N/A			
N/A	Gutter Ponding?	N/A	N/A	Gutter Slope (%)	N/A
N/A	Gutter Lip Ht (in)	N/A	N/A	Gutter X Slope (%)	N/A
N/A	Painted X Walk1?	Yes	N/A	Painted X Walk2?	N/A
	X Walk 1 Direction	To SE		X Walk 2 Direction	N/A
N/A	X Walk 1 Width (in)	103.0	N/A	X Walk 2 Width (in)	N/A
	X Walk 1 Slope (%)	2.4		X Walk 2 Slope (%)	N/A
	X Walk 1 X Slope (%)	1.3		X Walk 2 X Slope (%)	N/A

N/A	Ramp inside XWalk1?	Yes	N/A	Ramp inside XWalk2?	N/A
	Road Slope (%)	N/A	N/A	Clear Space?	N/A
	Road X Slope (%)	N/A	N/A	Clear Space to XWalk (in)	N/A
N/A	Any Obstructions?	N/A	N/A	Storm Grate/Utility Hazard?	N/A
	Obstruction Type			Storm Grate/Utility Type	
		N/A			N/A
			Yes	Surface Condition? (G/P)	Good

**Remove & Replace Entire Ramp.**
