# Access Compliance Report

## Public Rights-of-Way

### (Curb Ramps)

Intersection ID: 44001	Main Street: ELROSE_PL	Cross Street: N/A	Location: SE
ADA ID: 323A4334AA21	Ramp Type: BlendTrans1	Initial Pass/Fail: Fail	Overall Compliance: No
Codes/Mitigation Info/Possible Solution		Field Measurements/Component Compliance	
Severity Score: 12.5

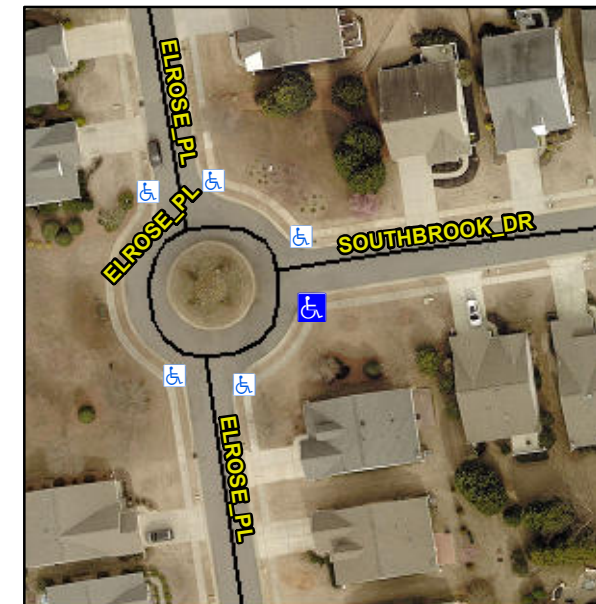
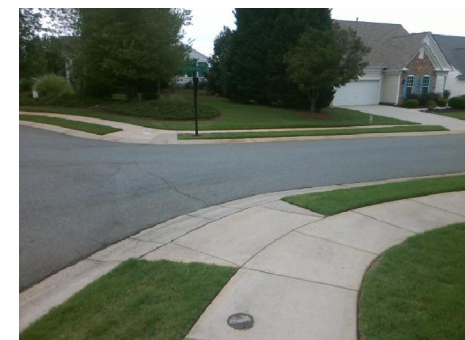
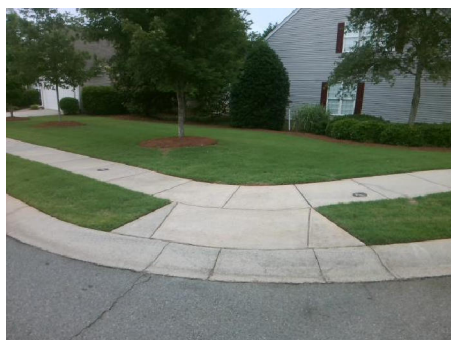
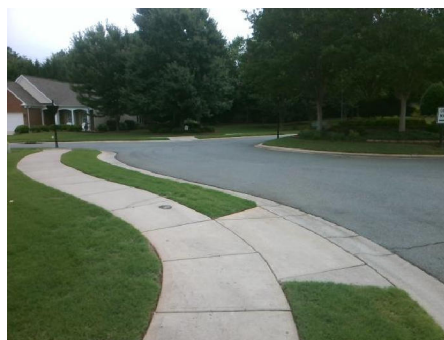
**Not Found, R304.5.3**

Compliance	Description	Data	Compliance	Description	Data
N/A	Ramp Length (in)	46.0	Yes	BlendTrans Slope (%)	4.0
Yes	Ramp Width (in)	75.0	No	BlendTrans XSlope (%)	6.3
N/A	Flare Type LT	N/A	N/A	Flare Type RT	N/A
N/A	Flare Slope LT (%)	N/A	N/A	Flare Slope RT (%)	N/A
N/A	Flare Traversable LT?	N/A	N/A	Flare Traversable RT?	N/A
N/A	Landing Length (in)	N/A	N/A	DWS Provided?	N/A
N/A	Landing Width (in)	N/A	N/A	DWS Contrast?	N/A
N/A	Landing Slope (%)	N/A	N/A	DWS Length (in)	N/A
N/A	Landing X Slope (%)	N/A	N/A	DWS Full Width?	N/A
N/A	Landing Curb? (Y/N)	N/A	N/A	DWS Offset (in)	N/A
N/A	Shared Landing?	N/A			
N/A	Gutter Ponding?	N/A	N/A	Gutter Slope (%)	N/A
N/A	Gutter Lip Ht (in)	N/A	N/A	Gutter X Slope (%)	N/A
N/A	Painted X Walk1?	No	N/A	Painted X Walk2?	N/A
	X Walk 1 Direction	To N		X Walk 2 Direction	N/A
	X Walk 1 Width (in)	N/A		X Walk 2 Width (in)	N/A
	X Walk 1 Slope (%)	2.1		X Walk 2 Slope (%)	N/A
	X Walk 1 X Slope (%)	6.8		X Walk 2 X Slope (%)	N/A

N/A	Ramp inside XWalk1?	N/A	N/A	Ramp inside XWalk2?	N/A
	Road Slope (%)	6.8		Clear Space?	N/A
	Road X Slope (%)	2.1	N/A	Clear Space to XWalk (in)	N/A
N/A	Any Obstructions?	N/A	N/A	Storm Grate/Utility Hazard?	N/A
	Obstruction Type			Storm Grate/Utility Type	
		N/A			N/A
			Yes	Surface Condition? (G/P)	Good
			No	Curb Slope (%)	26.6

**Remove & Replace Curb Ramp With Two New Directional Ramps or Equivalent.**
