Access Compliance Report

Public Rights-of-Way

(Curb Ramps)

| Intersection ID: 51510 | Main Street: KENILWORTH_AV | Cross Street: PEARL_PARK_WY | Location: NE |

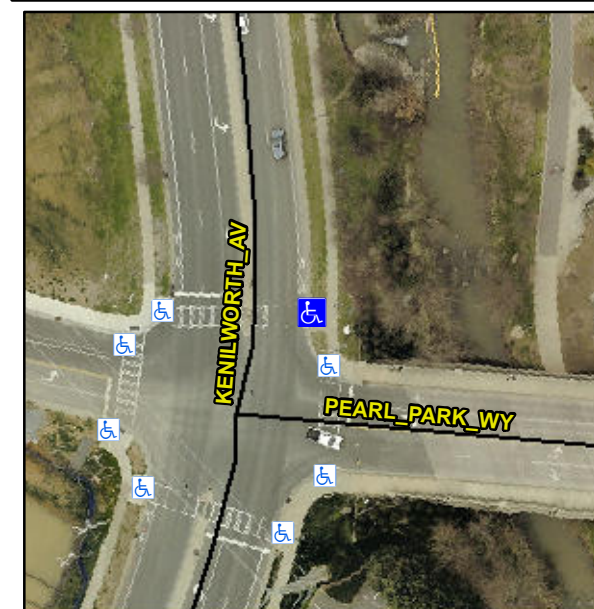
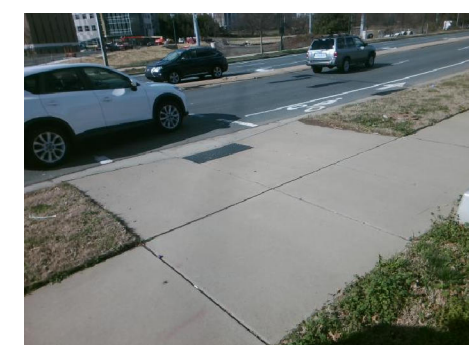
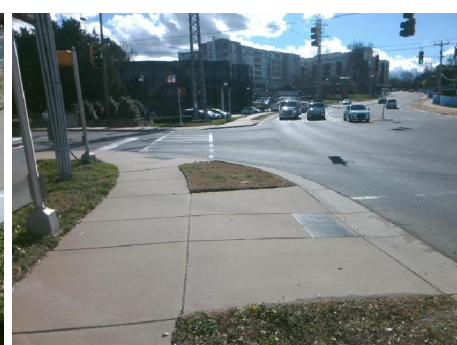
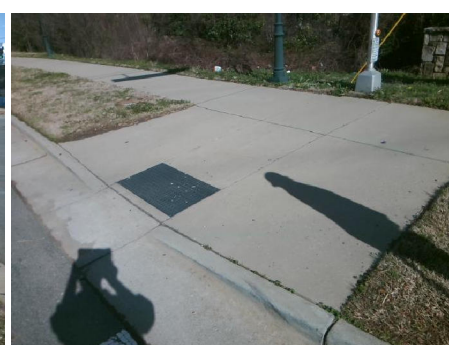
Not Found, R304.2.2

| Compliance | Description | Data | Compliance | Description | Data |
|---|---|---|---|---|---|
| N/A | Ramp Length (in) | 99.0 | No | Ramp Slope (%) | 8.6 |

Remove & Replace Entire Ramp.
