Access Compliance Report

Public Rights-of-Way

(Curb Ramps)

Intersection ID: N/A	Main Street: TAMARACK DR	Cross Street: SINGLELEAF LN	Location: E
ADA ID: 324B40A93A15	Ramp Type: Perp	Initial Pass/Fail: Fail	Overall Compliance: No
Severity Score: 13.75			
Codes/Mitigation Info/Possible Solution		Field Measurements/Component Compliance

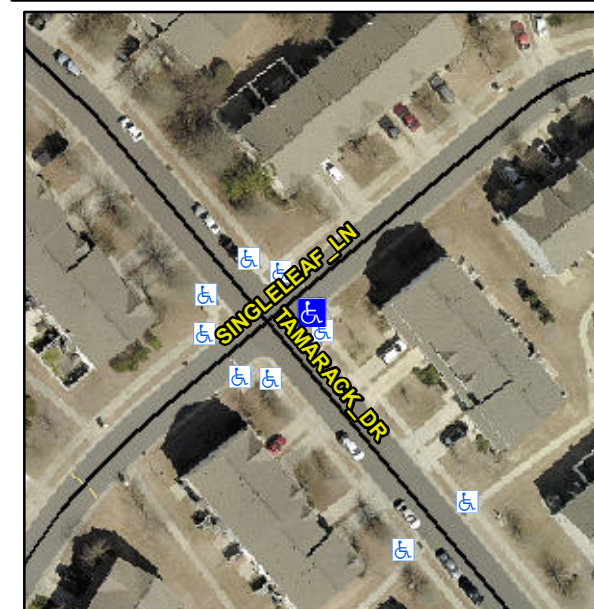
Not Found, R304.2.2, R304.5.3

Compliance	Description	Data	Compliance	Description	Data
N/A	Ramp Length (in)	48.0	No	Ramp Slope (%)	9.2
Yes	Ramp Width (in)	48.0	No	Ramp XSlope (%)	2.2
N/A	Flare Type LT	N/A	N/A	Flare Type RT	N/A
N/A	Flare Slope LT (%)	N/A	N/A	Flare Slope RT (%)	N/A
N/A	Flare Traversable LT?	No	N/A	Flare Traversable RT?	No
N/A	Landing Length (in)	N/A	N/A	DWS Provided?	N/A
N/A	Landing Width (in)	N/A	N/A	DWS Contrast?	N/A
N/A	Landing Slope (%)	N/A	N/A	DWS Length (in)	N/A
N/A	Landing X Slope (%)	N/A	N/A	DWS Full Width?	N/A
N/A	Landing Curb? (Y/N)	N/A	N/A	DWS Offset (in)	N/A
N/A	Shared Landing?	N/A			
N/A	Gutter Ponding?	N/A	N/A	Gutter Slope (%)	N/A
N/A	Gutter Lip Ht (in)	N/A	N/A	Gutter X Slope (%)	N/A
N/A	Painted X Walk1?	No	N/A	Painted X Walk2?	N/A
	X Walk 1 Direction	To NW		X Walk 2 Direction	N/A
N/A	X Walk 1 Width (in)	N/A	N/A	X Walk 2 Width (in)	N/A
	X Walk 1 Slope (%)	0.1		X Walk 2 Slope (%)	N/A
	X Walk 1 X Slope (%)	1.3		X Walk 2 X Slope (%)	N/A

N/A	Ramp inside XWalk1?	No	N/A	Ramp inside XWalk2?	N/A
	Road Slope (%)	N/A	N/A	Clear Space?	N/A
	Road X Slope (%)	N/A	N/A	Clear Space to XWalk (in)	N/A
N/A	Any Obstructions?	N/A	N/A	Storm Grate/Utility Hazard?	N/A
	Obstruction Type			Storm Grate/Utility Type	
		N/A			N/A
			Yes	Surface Condition? (G/P)	Good

Possible Solutions:

Remove & Replace Entire Ramp.
