Access Compliance Report Public Rights-of-Way (Curb Ramps)

Intersection ID: 51371 Main Street: UNIVERSITY_POINTE_BV Cross Street: N_TRYON_ST Location: SE **ADA ID: 3250B58E1CDC** Ramp Type: Perp Initial Pass/Fail: Fail **Overall Compliance: No Severity Score:** 10

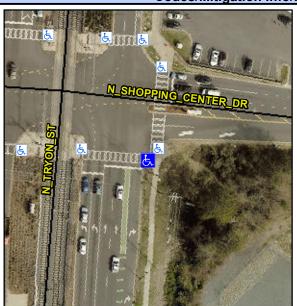
Field Measurements/Component Compliance								
Comp	liance Description	Data	Comp	liance Description	Data			
N/A	Ramp Length (in)	89.0	Yes	Ramp Slope (%)	8.0			
No	Ramp Width (in)	47.0	No	Ramp XSlope (%)	2.4			
N/A	Flare Type LT	N/A	N/A	Flare Type RT	N/A			
N/A	Flare Slope LT (%)	N/A	N/A	Flare Slope RT (%)	N/A			
N/A	Flare Traversable LT?	N/A	N/A	Flare Traversable RT?	N/A			
N/A	Landing Length (in)	N/A	N/A	DWS Provided?	N/A			
N/A	Landing Width (in)	N/A	N/A	DWS Contrast?	N/A			
N/A	Landing Slope (%)	N/A	N/A	DWS Length (in)	N/A			
N/A	Landing X Slope (%)	N/A	N/A	DWS Full Width?	N/A			
N/A	Landing Curb? (Y/N)	N/A	N/A	DWS Offset (in)	N/A			
N/A	Shared Landing?	N/A						
N/A	Gutter Ponding?	N/A	N/A	Gutter Slope (%)	N/A			
N/A	Gutter Lip Ht (in)	N/A	N/A	Gutter X Slope (%)	N/A			
N/A	Painted X Walk1?	No	N/A	Painted X Walk2?	N/A			
	X Walk 1 Direction	To W		X Walk 2 Direction	N/A			
N/A	X Walk 1 Width (in)	N/A	N/A	X Walk 2 Width (in)	N/A

X Walk 1 Slope (%)	4.2		X Walk 2 Slope (%)	N/A			
	X Walk 1 X Slope (%)	1.6		X Walk 2 X Slope (%)	N/A			
N/A	Ramp inside XWalk1?	N/A	N/A	Ramp inside XWalk2?	N/A			
	Road Slope (%)	N/A	N/A	Clear Space?	N/A			
	Road X Slope (%)	N/A	N/A	Clear Space to XWalk (in)	N/A			
N/A	Any Obstructions?	N/A	N/A	Storm Grate/Utility Hazard?	N/A			
	Obstruction Type			Storm Grate/Utility Type				
		N/A			N/A			
			Yes	Surface Condition? (G/P)	Good

Possible Solutions:	Co
Remove & Replace Entire Ramp.	
·	No
	N/A
	N/A
	N/A
	N/
Surveyor Notes:	N/
N/A	N/A
	N/A
	N/A
	N/A
PROW/ADA:	N/
Not Found, R304.5.1, R304.5.3	N/A
,	N/A
	N/
	N/
