Access Compliance Report Public Rights-of-Way (Curb Ramps)

Intersection ID: 10566	: 10566 Main Street: TACOMA_ST			Cross Street: FORESTBROOK_DR					Location:	N/A	
ADA ID: 32572C811951	i1 Ramp Type: Perp			Initial Pass/Fail: Fail Overall Compliance: No				o Severity Score:	37.5		
Codes/Mitigation Info/Possible Solution					Field Measurements/Component Compliance

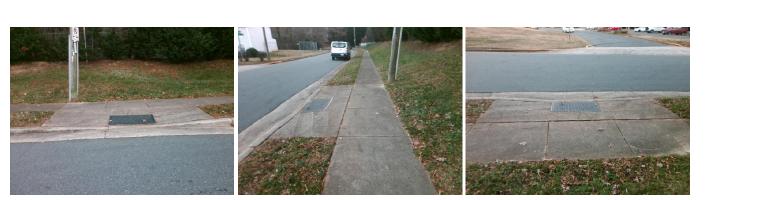
-	Possible Solutions:			Compliance Description			Data Compliance Description			
8 8 N		Remove & Replace Entit	re Ramp		N/A	Ramp Length (in)	48.0	No	Ramp Slope (%)	12.9	
The second se	8112		•		Yes	Ramp Width (in)	48.0	No	Ramp XSlope (%)	6.8	
	all an				N/A	Flare Type LT	N/A	N/A	Flare Type RT	N/A	
A INSTALLER	Jonan Will				N/A	Flare Slope LT (%)	N/A	N/A	Flare Slope RT (%)	N/A	
					N/A	Flare Traversable LT?	N/A	N/A	Flare Traversable RT?	N/A	
	OK DR	4			N/A	Landing Length (in)	N/A	N/A	DWS Provided?	N/A	
RESTERO	No. Contraction	Surveyor Notes:			N/A	Landing Width (in)	N/A	N/A	DWS Contrast?	N/A	
Fold		N/A			N/A	Landing Slope (%)	N/A	N/A	DWS Length (in)	N/A	
Se and a second	AND COMPANY				N/A	Landing X Slope (%)	N/A	N/A	DWS Full Width?	N/A	
	S				N/A	Landing Curb? (Y/N)	N/A	N/A	DWS Offset (in)	N/A	
					N/A	Shared Landing?	N/A				
and the second		PROW/ADA:			N/A	Gutter Ponding?	N/A	N/A	Gutter Slope (%)	N/A

1 IL I	Not Found, R304.2.2, R3	04.5.3		N/A	Gutter Lip Ht (in)	N/A	N/A	Gutter X Slope (%)	N/A	
	1 1 11	·····,····,·····,·····,·····,····	•		N/A	Painted X Walk1?	No	N/A	Painted X Walk2?	N/A	
E / Land					X Walk 1 Direction	To N		X Walk 2 Direction	N/A

- Stand E				N/A	X Walk 1 Width (in)	N/A	N/A	X Walk 2 Width (in)	N/A		
Street 1 Name	FORESTBROOK DR	-				X Walk 1 Slope (%)	3.2		X Walk 2 Slope (%)	N/A	
Stop Condition-Street 2	None					X Walk 1 X Slope (%)	7.7		X Walk 2 X Slope (%)	N/A	
Street 2 Name	N/A				N/A	Ramp inside XWalk1?	N/A	N/A	Ramp inside XWalk2?	N/A	
Stop Condition-Street 1	N/A					Road Slope (%)	7.7	N/A	Clear Space?	N/A	
						Road X Slope (%)	3.2	N/A	Clear Space to XWalk (in)	N/A	
					N/A	Any Obstructions?	N/A	N/A	Storm Grate/Utility Hazard?	N/A	
		Total Cost:	\$	1850.00		Obstruction Type			Storm Grate/Utility Type		
							N/A			N/A
