## **Access Compliance Report Public Rights-of-Way** (Curb Ramps)

Main Street: GARNETTE PL Intersection ID: 8552 **Cross Street: MITCHELL ST** Location: SW Initial Pass/Fail: Fail **Overall Compliance: No** 25 ADA ID: 326943968EC4 Ramp Type: Combination2 **Severity Score:**

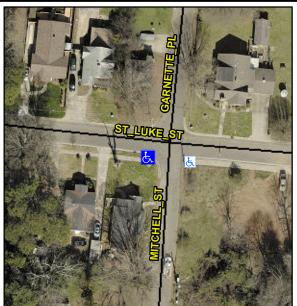
Street 1 Name Signal MITCHELL ST Stop Condition-Street 1 Street 2 Name N/A Stop Condition-Street 2 N/A Possible Solutions: Remove & Replace Entire Ramp. Surveyor Notes: N/A PROW/ADA: Not Found, R304.5.1, R304.5.3, R304.3.2
