Access Compliance Report Public Rights-of-Way (Curb Ramps)

Intersection ID: 31410Main Street: BLACK_FOX_CTCross Street: OLD_WAGON_RDLocation:SEADA ID: 32759718E95BRamp Type: Combination2Initial Pass/Fail: FailOverall Compliance: NoSeverity Score:25

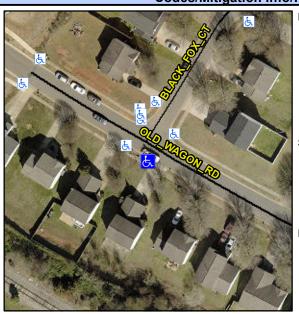
Not Found, R304.5.1, R304.5.1,
R304.2.2, R304.5.3

N/A	Ramp XSlope LT (%)	N/A	Yes	Ramp XSlope RT (%)	0.4
N/A	Ramp Length (in)	47.5	No	Ramp Slope (%)	9.7
No	Ramp Width (in)	47.0	No	Ramp XSlope (%)	5.3
N/A	Flare Type LT	N/A	N/A	Flare Type RT	N/A
N/A	Flare Slope LT (%)	N/A	N/A	Flare Slope RT (%)	N/A
N/A	Flare Traversable LT?	N/A	N/A	Flare Traversable RT?	N/A
N/A	Landing Length (in)	N/A	N/A	DWS Provided?	N/A
N/A	Landing Width (in)	N/A	N/A	DWS Contrast?	N/A
N/A	Landing Slope (%)	N/A	N/A	DWS Length (in)	N/A
N/A	Landing X Slope (%)	N/A	N/A	DWS Full Width?	N/A
N/A	Landing Curb? (Y/N)	N/A	N/A	DWS Offset (in)	N/A
N/A	Shared Landing?	N/A			
N/A	Gutter Ponding?	N/A	N/A	Gutter Slope (%)	N/A
N/A	Gutter Lip Ht (in)	N/A	N/A	Gutter X Slope (%)	N/A
N/A	Painted X Walk1?	No	N/A	Painted X Walk2?	N/A
	X Walk 1 Direction	To N		X Walk 2 Direction	N/A
	X Walk 1 Width (in)	N/A		X Walk 2 Width (in)	N/A
	X Walk 1 Slope (%)	0.7		X Walk 2 Slope (%)	N/A
	X Walk 1 X Slope (%)	3.9		X Walk 2 X Slope (%)	N/A

Remove & Replace Entire Ramp.
