Access Compliance Report

Public Rights-of-Way

(Curb Ramps)

Intersection ID: 24930	Main Street: KING_EIDER_DR	Cross Street: CHOATE_CR	Location: NW
ADA ID: 3280566204B7	Ramp Type: Directional1	Initial Pass/Fail: Fail	Overall Compliance: No
			Severity Score: 26.25

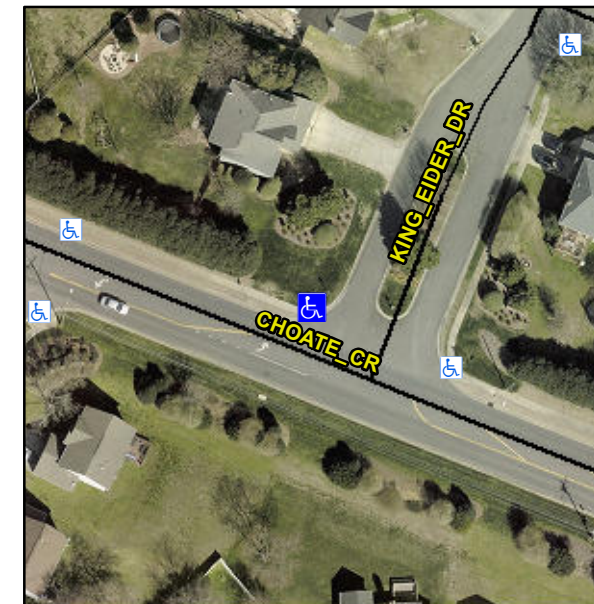
R304.2.2, R304.5.3

Compliance	Description	Data	Compliance	Description	Data
N/A	Ramp Length (in)	53.0	N/A	Grade Break?	N/A
Yes	Ramp Width (in)	48.0	N/A	Grade Break Slope (%)	0.0
No	Ramp Slope (%)	12.9	N/A	Grade Break XSlope (%)	0.0
No	Ramp XSlope (%)	2.8			
N/A	Flare Type LT	N/A	N/A	Flare Type RT	N/A
N/A	Flare Slope LT (%)	N/A	N/A	Flare Slope RT (%)	0.0
N/A	Flare Traversable LT?	N/A	N/A	Flare Traversable RT?	N/A
N/A	Landing Length (in)	0.0	N/A	DWS Provided?	N/A
N/A	Landing Width (in)	0.0	N/A	DWS Contrast?	N/A
N/A	Landing Slope (%)	0.0	N/A	DWS Length (in)	N/A
N/A	Landing X Slope (%)	0.0	N/A	DWS Full Width?	N/A
N/A	Landing Curb? (Y/N)	N/A	N/A	DWS Offset LT (in)	N/A
N/A	Shared Landing?	N/A	N/A	DWS Offset RT (in)	N/A
N/A	Gutter Ponding?	0.0	N/A	Gutter Slope (%)	N/A
N/A	Gutter Lip Ht (in)	0.0	N/A	Gutter X Slope (%)	N/A
N/A	Painted X Walk1?	No		Road Slope (%)	1.4
	X Walk 1 Direction	To E		Road X Slope (%)	4.6
	X Walk 1 Width (in)	N/A		Clear Space?	N/A

X Walk 1 Slope (%)	1.4	N/A	Clear Space to XWalk (in)	N/A
	X Walk 1 X Slope (%)	4.6	N/A	Storm Grate/Utility Hazard?	N/A
N/A	Ramp inside XWalk1?	N/A		Storm Grate/Utility Type	
N/A	Any Obstructions?	N/A			N/A
	Obstruction Type		Yes	Surface Condition? (G/P)	Good
			N/A	Curb Slope (%)	3.2

Remove & Replace Entire Ramp.

Total Cost: \$ 1600.00
