Access Compliance Report

Public Rights-of-Way

(Curb Ramps)

Intersection ID: 21011	Main Street: CORONATION_BV	Cross Street: SARDIS_RD_NORTH	Location: S
ADA ID: 3280AD6B425C	Ramp Type: Perp	Initial Pass/Fail: Fail	Overall Compliance: No
Severity Score: 50			
Codes/Mitigation Info/Possible Solution		Field Measurements/Component Compliance

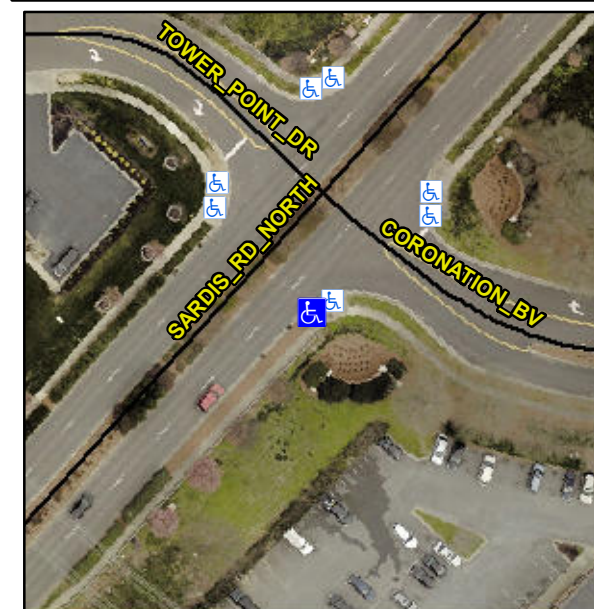
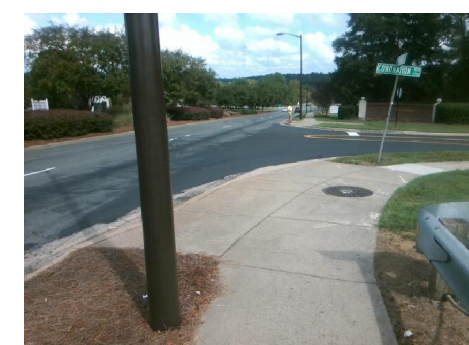
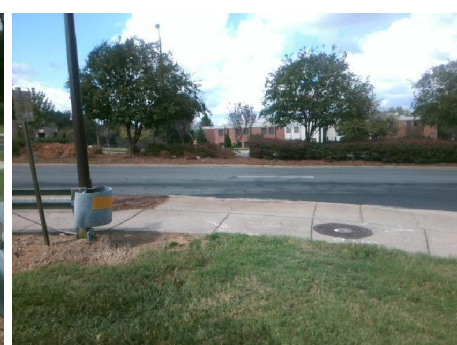
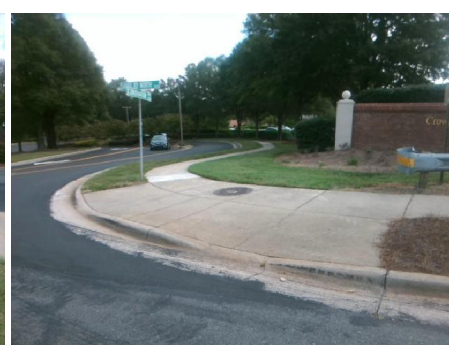
Not Found, R304.2.2, R304.5.3

Compliance	Description	Data	Compliance	Description	Data
N/A	Ramp Length (in)	64.5	No	Ramp Slope (%)	12.9
Yes	Ramp Width (in)	48.0	No	Ramp XSlope (%)	7.1
N/A	Flare Type LT	N/A	N/A	Flare Type RT	N/A
N/A	Flare Slope LT (%)	N/A	N/A	Flare Slope RT (%)	N/A
N/A	Flare Traversable LT?	N/A	N/A	Flare Traversable RT?	N/A
N/A	Landing Length (in)	N/A	N/A	DWS Provided?	N/A
N/A	Landing Width (in)	N/A	N/A	DWS Contrast?	N/A
N/A	Landing Slope (%)	N/A	N/A	DWS Length (in)	N/A
N/A	Landing X Slope (%)	N/A	N/A	DWS Full Width?	N/A
N/A	Landing Curb? (Y/N)	N/A	N/A	DWS Offset (in)	N/A
N/A	Shared Landing?	N/A			
N/A	Gutter Ponding?	N/A	N/A	Gutter Slope (%)	N/A
N/A	Gutter Lip Ht (in)	N/A	N/A	Gutter X Slope (%)	N/A
N/A	Painted X Walk1?	No	N/A	Painted X Walk2?	N/A
	X Walk 1 Direction	To NW		X Walk 2 Direction	N/A
N/A	X Walk 1 Width (in)	N/A	N/A	X Walk 2 Width (in)	N/A
	X Walk 1 Slope (%)	3.4		X Walk 2 Slope (%)	N/A
	X Walk 1 X Slope (%)	4.9		X Walk 2 X Slope (%)	N/A

N/A	Ramp inside XWalk1?	N/A	N/A	Ramp inside XWalk2?	N/A
	Road Slope (%)	N/A	N/A	Clear Space?	N/A
	Road X Slope (%)	N/A	N/A	Clear Space to XWalk (in)	N/A
N/A	Any Obstructions?	N/A	N/A	Storm Grate/Utility Hazard?	N/A
	Obstruction Type			Storm Grate/Utility Type	
		N/A			N/A
			Yes	Surface Condition? (G/P)	Good

Remove & Replace Entire Ramp.
