# Access Compliance Report

## Public Rights-of-Way

### (Curb Ramps)

Intersection ID: 47613	Main Street: BATHURST_DR	Cross Street: MACQUARIE_LN	Location: NE
ADA ID: 3299F03C9D3E	Ramp Type: PerpDiag	Initial Pass/Fail: Fail	Overall Compliance: No
Severity Score: 10			
Codes/Mitigation Info/Possible Solution		Field Measurements/Component Compliance

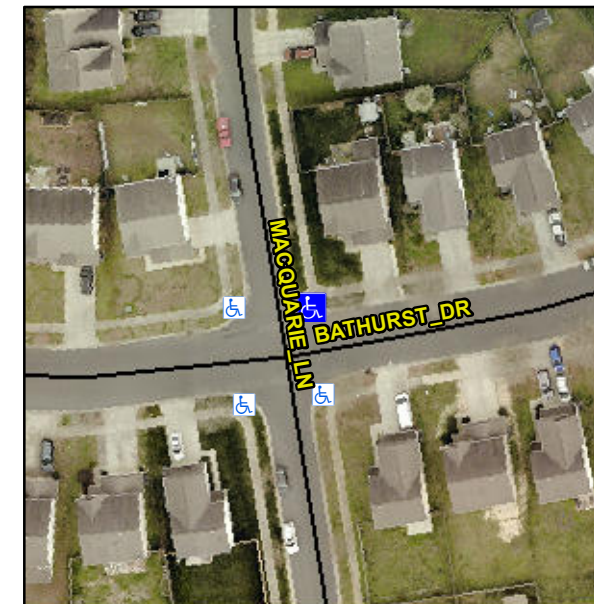
**Not Found, R304.5.1, R304.5.3**

Compliance	Description	Data	Compliance	Description	Data
N/A	Ramp Length (in)	54.0	Yes	Ramp Slope (%)	5.1
No	Ramp Width (in)	43.0	No	Ramp XSlope (%)	3.6
N/A	Flare Type LT	N/A	N/A	Flare Type RT	N/A
N/A	Flare Slope LT (%)	N/A	N/A	Flare Slope RT (%)	N/A
N/A	Flare Traversable LT?	N/A	N/A	Flare Traversable RT?	N/A
N/A	Landing Length (in)	N/A	N/A	DWS Provided?	N/A
N/A	Landing Width (in)	N/A	N/A	DWS Contrast?	N/A
N/A	Landing Slope (%)	N/A	N/A	DWS Length (in)	N/A
N/A	Landing X Slope (%)	N/A	N/A	DWS Full Width?	N/A
N/A	Landing Curb? (Y/N)	N/A	N/A	DWS Offset (in)	N/A
N/A	Shared Landing?	N/A			
N/A	Gutter Ponding?	N/A	N/A	Gutter Slope (%)	N/A
N/A	Gutter Lip Ht (in)	N/A	N/A	Gutter X Slope (%)	N/A
N/A	Painted X Walk1?	No	N/A	Painted X Walk2?	No
	X Walk 1 Direction	To W		X Walk 2 Direction	To S
N/A	X Walk 1 Width (in)	N/A	N/A	X Walk 2 Width (in)	N/A
	X Walk 1 Slope (%)	0.2		X Walk 2 Slope (%)	1.6
	X Walk 1 X Slope (%)	0.3		X Walk 2 X Slope (%)	0.1

N/A	Ramp inside XWalk1?	N/A	N/A	Ramp inside XWalk2?	N/A
	Road Slope (%)	1.2	N/A	Clear Space?	N/A
	Road X Slope (%)	1.0	N/A	Clear Space to XWalk (in)	N/A
N/A	Any Obstructions?	N/A	N/A	Storm Grate/Utility Hazard?	N/A
	Obstruction Type			Storm Grate/Utility Type	
		N/A			N/A
		Yes		Surface Condition? (G/P)	Good

**Remove & Replace Curb Ramp With Two New Directional Ramps or Equivalent.**

Total Cost: \$ 3200.00
