Access Compliance Report Public Rights-of-Way (Curb Ramps)

Intersection ID: 19520	0 Main Street: SARDIS_RD				Street.	TIMBER_LN	Location:	SE		
ADA ID: 329C16CD732A Ramp Type: Perp			Initial	Initial Pass/Fail: Fail Overall Compliance: No				o Severity Score:	37.5	
Codes/Mitigation Info/Possible Solution				Field Measurements/Component Compliance						
	1 4	Possible Solutions:			Compliance Description			Data Compliance Description		
	100	Remove & Replace Entir	re Ram	ıp.	N/A	Ramp Length (in)	60.0	No	Ramp Slope (%)	9.6
0 10	1 them			-	Yes	Ramp Width (in)	48.0	No	Ramp XSlope (%)	10.4
ANA -	A star				N/A	Flare Type LT	N/A	N/A	Flare Type RT	N/A
		8			N/A	Flare Slope LT (%)	N/A	N/A	Flare Slope RT (%)	N/A
A CONTRACT OF A	19. 5				N/A	Flare Traversable LT?	N/A	N/A	Flare Traversable RT?	N/A
					N/A	Landing Length (in)	N/A	N/A	DWS Provided?	N/A
Mania St.		Surveyor Notes:			N/A	Landing Width (in)	N/A	N/A	DWS Contrast?	N/A
	and the second	N/A			N/A	Landing Slope (%)	N/A	N/A	DWS Length (in)	N/A

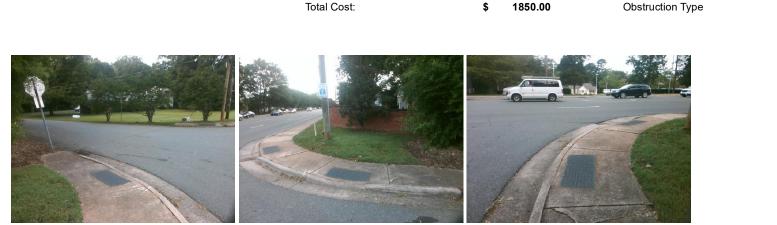
E.					N/A	Landing X Slope (%)	N/A	N/A	DWS Full Width?	N/A
86.		4			N/A	Landing Curb? (Y/N)	N/A	N/A	DWS Offset (in)	N/A
	me soft				N/A	Shared Landing?	N/A			
R	A CARLON	PROW/ADA:			N/A	Gutter Ponding?	N/A	N/A	Gutter Slope (%)	N/A
	SH BER	Not Found, R304.2.2, R3	04.5.3		N/A	Gutter Lip Ht (in)	N/A	N/A	Gutter X Slope (%)	N/A
All and the second					N/A	Painted X Walk1?	No	N/A	Painted X Walk2?	N/A
States and the second						X Walk 1 Direction	To SW		X Walk 2 Direction	N/A
11 - CATER - 1200				N/A	X Walk 1 Width (in)	N/A	N/A	X Walk 2 Width (in)	N/A	
Street 1 Name	TIMBER LN					X Walk 1 Slope (%)	0.5		X Walk 2 Slope (%)	N/A
Stop Condition-Street 2	StopSign					X Walk 1 X Slope (%)	5.4		X Walk 2 X Slope (%)	N/A
Street 2 Name	N/A				N/A	Ramp inside XWalk1?	N/A	N/A	Ramp inside XWalk2?	N/A
Stop Condition-Street 1	N/A					Road Slope (%)	N/A	N/A	Clear Space?	N/A
						Road X Slope (%)	N/A	N/A	Clear Space to XWalk (in)	N/A

N/A	Any Obstructions?	N/A	N/A	Storm Grate/Utility Hazard?	N/A
		Total Cost:	\$	1850.00		Obstruction Type			Storm Grate/Utility Type	
							N/A			N/A
