Access Compliance Report Public Rights-of-Way (Curb Ramps)

Intersection ID: 49003	Main St	Main Street: STEELE_CREEK_RD			Cross Street: STEELECROFT_PY				Location:	SW	
ADA ID: 329D6C24B16D	Ramp Type: Perp			Initial	Initial Pass/Fail: Fail Overall Compliance: No				o Severity Score:	8.75	
Codes/Mitigation Info/Possible Solution					Field Measurements/Component Compliance						
		Possible Solutions:		Compliance Description			Data Compliance Description				
		Remove & Replace Entire	Ram	ip.	N/A	Ramp Length (in)	90.0	Yes	Ramp Slope (%)	5.1	
KD IF	<u>E.</u>			•	No	Ramp Width (in)	46.0	Yes	Ramp XSlope (%)	2.0

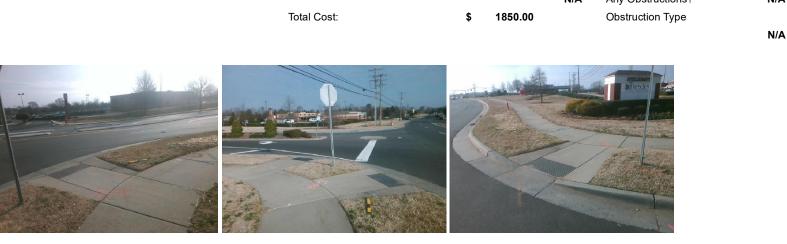
Street 1 Name STEEL	E CREEK RD	_				X Walk 1 Slope (%)	3.4		X Walk 2 Slope (%)	N/A	
Stop Condition-Street 2	None					X Walk 1 X Slope (%)	2.9		X Walk 2 X Slope (%)	N/A	
Street 2 Name	N/A				N/A	Ramp inside XWalk1?	N/A	N/A	Ramp inside XWalk2?	N/A	
Stop Condition-Street 1	N/A					Road Slope (%)	N/A	N/A	Clear Space?	N/A	
						Road X Slope (%)	N/A	N/A	Clear Space to XWalk (in)	N/A	
					N/A	Any Obstructions?	N/A	N/A	Storm Grate/Utility Hazard?	N/A	
		Total Cost:	\$	1850.00		Obstruction Type			Storm Grate/Utility Type		
							N/A			N/A
