Access Compliance Report

Public Rights-of-Way

(Curb Ramps)

Intersection ID: 47612	Main Street: MACQUARIE_LN	Cross Street: BATHURST_DR	Location:	N
ADA ID: 329EB8982304	Ramp Type: PerpDiag	Initial Pass/Fail: Fail	Overall Compliance: No	Severity Score: 10
Codes/Mitigation Info/Possible Solution		Field Measurements/Component Compliance

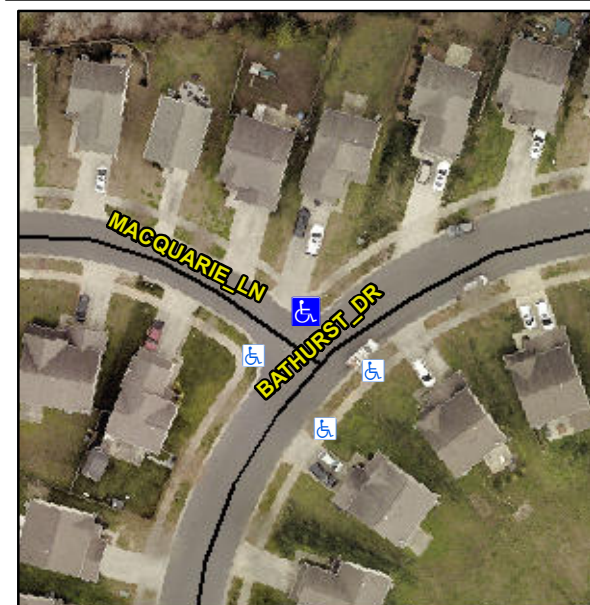
Compliance	Description	Data	Compliance	Description	Data
N/A	Ramp Length (in)	71.0	Yes	Ramp Slope (%)	5.2
No	Ramp Width (in)	42.0	No	Ramp XSlope (%)	2.6
N/A	Flare Type LT	N/A	N/A	Flare Type RT	N/A
N/A	Flare Slope LT (%)	N/A	N/A	Flare Slope RT (%)	N/A
N/A	Flare Traversable LT?	N/A	N/A	Flare Traversable RT?	N/A
N/A	Landing Length (in)	N/A	N/A	DWS Provided?	N/A
N/A	Landing Width (in)	N/A	N/A	DWS Contrast?	N/A
N/A	Landing Slope (%)	N/A	N/A	DWS Length (in)	N/A
N/A	Landing X Slope (%)	N/A	N/A	DWS Full Width?	N/A
N/A	Landing Curb? (Y/N)	N/A	N/A	DWS Offset (in)	N/A
N/A	Shared Landing?	N/A			
N/A	Gutter Ponding?	N/A	N/A	Gutter Slope (%)	N/A
N/A	Gutter Lip Ht (in)	N/A	N/A	Gutter X Slope (%)	N/A
N/A	Painted X Walk1?	No	N/A	Painted X Walk2?	No
	X Walk 1 Direction	To SW		X Walk 2 Direction	To SE
N/A	X Walk 1 Width (in)	N/A	N/A	X Walk 2 Width (in)	N/A
	X Walk 1 Slope (%)	2.7		X Walk 2 Slope (%)	3.3
	X Walk 1 X Slope (%)	4.1		X Walk 2 X Slope (%)	0.5

N/A	Ramp inside XWalk1?	N/A	N/A	Ramp inside XWalk2?	N/A
	Road Slope (%)	3.8	N/A	Clear Space?	N/A
	Road X Slope (%)	4.0	N/A	Clear Space to XWalk (in)	N/A
N/A	Any Obstructions?	N/A	N/A	Storm Grate/Utility Hazard?	N/A
	Obstruction Type			Storm Grate/Utility Type	
		N/A			N/A
			Yes	Surface Condition? (G/P)	Good

Possible Solutions:

Remove & Replace Curb Ramp With Two New Directional Ramps or Equivalent.
