Access Compliance Report

Public Rights-of-Way

(Curb Ramps)

Intersection ID: 26103	Main Street: BEVINGTON_PL	Cross Street: COBURN_CT	Location: S
ADA ID: 32B0D6C55F5D	Ramp Type: PerpDiag	Initial Pass/Fail: Fail	Overall Compliance: No
Severity Score: 8.75			
Codes/Mitigation Info/Possible Solution		Field Measurements/Component Compliance

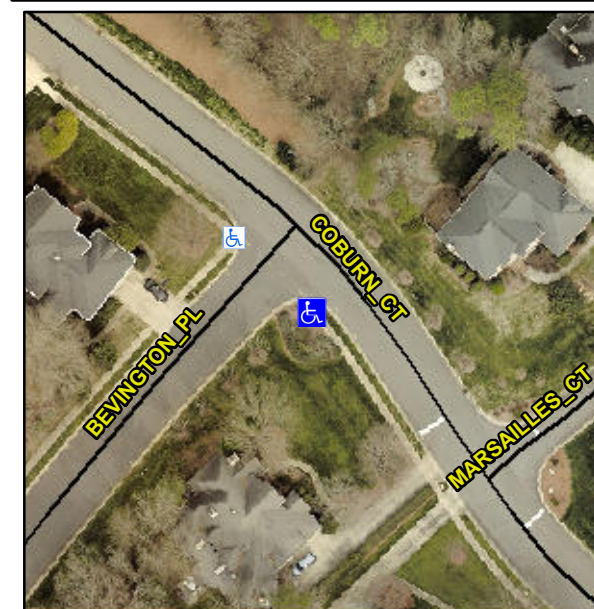
Not Found, R304.5.1

Compliance	Description	Data	Compliance	Description	Data
N/A	Ramp Length (in)	59.0	Yes	Ramp Slope (%)	5.2
No	Ramp Width (in)	44.0	Yes	Ramp XSlope (%)	0.7
N/A	Flare Type LT	N/A	N/A	Flare Type RT	N/A
N/A	Flare Slope LT (%)	N/A	N/A	Flare Slope RT (%)	N/A
N/A	Flare Traversable LT?	N/A	N/A	Flare Traversable RT?	N/A
N/A	Landing Length (in)	N/A	N/A	DWS Provided?	N/A
N/A	Landing Width (in)	N/A	N/A	DWS Contrast?	N/A
N/A	Landing Slope (%)	N/A	N/A	DWS Length (in)	N/A
N/A	Landing X Slope (%)	N/A	N/A	DWS Full Width?	N/A
N/A	Landing Curb? (Y/N)	N/A	N/A	DWS Offset (in)	N/A
N/A	Shared Landing?	N/A			
N/A	Gutter Ponding?	N/A	N/A	Gutter Slope (%)	N/A
N/A	Gutter Lip Ht (in)	N/A	N/A	Gutter X Slope (%)	N/A
N/A	Painted X Walk1?	No	N/A	Painted X Walk2?	No
	X Walk 1 Direction	To NE		X Walk 2 Direction	To NW
N/A	X Walk 1 Width (in)	N/A	N/A	X Walk 2 Width (in)	N/A
	X Walk 1 Slope (%)	4.1		X Walk 2 Slope (%)	3.9
	X Walk 1 X Slope (%)	0.9		X Walk 2 X Slope (%)	3.8

N/A	Ramp inside XWalk1?	N/A	N/A	Ramp inside XWalk2?	N/A
	Road Slope (%)	0.5	N/A	Clear Space?	N/A
	Road X Slope (%)	2.8	N/A	Clear Space to XWalk (in)	N/A
N/A	Any Obstructions?	N/A	N/A	Storm Grate/Utility Hazard?	N/A
	Obstruction Type			Storm Grate/Utility Type	
		N/A			N/A
		Yes		Surface Condition? (G/P)	Good

Possible Solutions:

Remove & Replace Curb Ramp With Two New Directional Ramps or Equivalent.
