# Access Compliance Report

## Public Rights-of-Way

Intersection ID: 53016	Main Street: STEEL_HOUSE_BV	Cross Street: BESSEMER_ST	Location: SE
ADA ID: 32B1F19B86F6	Ramp Type: Perp	Initial Pass/Fail: Pass	Overall Compliance: No
Codes/Mitigation Info/Possible Solution		Field Measurements/Component Compliance	
Severity Score: 10

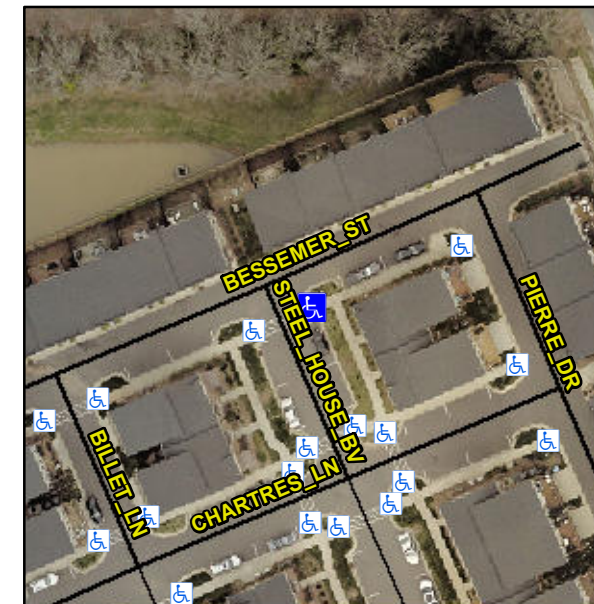
Compliance	Description	Data	Compliance	Description	Data
N/A	Ramp Length (in)	142.0	Yes	Ramp Slope (%)	6.0
Yes	Ramp Width (in)	60.0	Yes	Ramp XSlope (%)	1.3
N/A	Flare Type LT	None	N/A	Flare Type RT	N/A
N/A	Flare Slope LT (%)	N/A	N/A	Flare Slope RT (%)	N/A
N/A	Flare Traversable LT?	N/A	N/A	Flare Traversable RT?	N/A
Yes	Landing Length (in)	60.0	Yes	DWS Provided?	Yes
Yes	Landing Width (in)	60.0	Yes	DWS Contrast?	Yes
Yes	Landing Slope (%)	0.8	Yes	DWS Length (in)	24.0
No	Landing X Slope (%)	4.6	No	DWS Full Width?	No
N/A	Landing Curb? (Y/N)	No	No	DWS Offset (in)	12.0
N/A	Shared Landing?	No			
Yes	Gutter Ponding?	No	Yes	Gutter Slope (%)	2.9
No	Gutter Lip Ht (in)	0.5	Yes	Gutter X Slope (%)	2.0
N/A	Painted X Walk1?	Yes	N/A	Painted X Walk2?	N/A
	X Walk 1 Direction	To SW		X Walk 2 Direction	N/A
N/A	X Walk 1 Width (in)	66.5	N/A	X Walk 2 Width (in)	N/A
	X Walk 1 Slope (%)	0.8		X Walk 2 Slope (%)	N/A
	X Walk 1 X Slope (%)	3.0		X Walk 2 X Slope (%)	N/A

Yes	Ramp inside XWalk1?	Yes	N/A	Ramp inside XWalk2?	N/A
	Road Slope (%)	N/A	N/A	Clear Space?	Yes
	Road X Slope (%)	N/A	N/A	Clear Space to XWalk (in)	N/A
Yes	Any Obstructions?	No	Yes	Storm Grate/Utility Hazard?	No
	Obstruction Type			Storm Grate/Utility Type	
		N/A			N/A
		Yes		Surface Condition? (G/P)	Good

**Remove & Replace Entire Ramp.  
Grind Gutter Lip.**
