Access Compliance Report

Public Rights-of-Way

(Curb Ramps)

| Intersection ID: 14014 | Main Street: N_SHARON_AMITY_RD | Cross Street: WILORA_LAKE_RD | Location: NE |

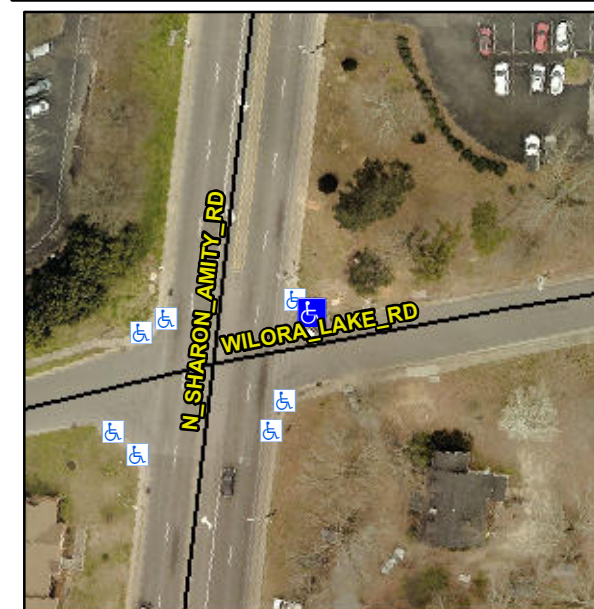
| ADA ID: 32E42BC511F8 | Ramp Type: Perp | Initial Pass/Fail: Fail | Overall Compliance: No |
| Severity Score: 21.25 | | | |

Not Found, R304.5.1, R304.2.2

| Compliance | Description | Data | Compliance | Description | Data |
|---|---|---|---|---|---|
| N/A | Ramp Length (in) | 58.0 | No | Ramp Slope (%) | 11.1 |
| No | Ramp Width (in) | 42.0 | Yes | Ramp XSlope (%) | 1.4 |
| N/A | Gutter Ponding? | Yes | N/A | Gutter Slope (%) | N/A |

Possible Solutions:

Remove & Replace Entire Ramp.
