Access Compliance Report

Public Rights-of-Way

(Curb Ramps)

Intersection ID: 29136	Main Street: DEATON_HILL_DR	Cross Street: FOREST_GROVE_CT	Location: W
ADA ID: 32E8DB9828F8	Ramp Type: PerpDiag	Initial Pass/Fail: Fail	Overall Compliance: No
Severity Score: 12.5			
Codes/Mitigation Info/Possible Solution		Field Measurements/Component Compliance

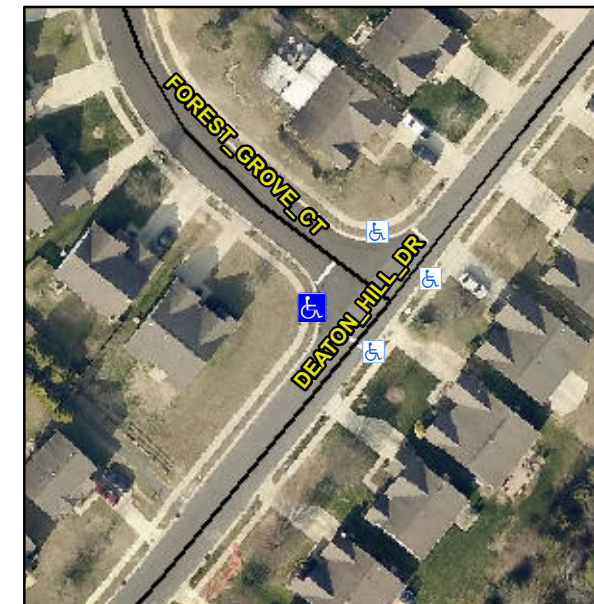
Compliance	Description	Data	Compliance	Description	Data
N/A	Ramp Length (in)	50.0	No	Ramp Slope (%)	9.2
Yes	Ramp Width (in)	48.0	Yes	Ramp XSlope (%)	0.3
N/A	Flare Type LT	N/A	N/A	Flare Type RT	N/A
N/A	Flare Slope LT (%)	N/A	N/A	Flare Slope RT (%)	N/A
N/A	Flare Traversable LT?	N/A	N/A	Flare Traversable RT?	N/A
N/A	Landing Length (in)	N/A	N/A	DWS Provided?	N/A
N/A	Landing Width (in)	N/A	N/A	DWS Contrast?	N/A
N/A	Landing Slope (%)	N/A	N/A	DWS Length (in)	N/A
N/A	Landing X Slope (%)	N/A	N/A	DWS Full Width?	N/A
N/A	Landing Curb? (Y/N)	N/A	N/A	DWS Offset (in)	N/A
N/A	Shared Landing?	N/A			
N/A	Gutter Ponding?	N/A	N/A	Gutter Slope (%)	N/A
N/A	Gutter Lip Ht (in)	N/A	N/A	Gutter X Slope (%)	N/A
N/A	Painted X Walk1?	No	N/A	Painted X Walk2?	No
	X Walk 1 Direction	To SE		X Walk 2 Direction	To NE
N/A	X Walk 1 Width (in)	N/A	N/A	X Walk 2 Width (in)	N/A
	X Walk 1 Slope (%)	6.1		X Walk 2 Slope (%)	7.1
	X Walk 1 X Slope (%)	5.7		X Walk 2 X Slope (%)	5.0

N/A	Ramp inside XWalk1?	N/A	N/A	Ramp inside XWalk2?	N/A
	Road Slope (%)	0.6	N/A	Clear Space?	N/A
	Road X Slope (%)	7.6	N/A	Clear Space to XWalk (in)	N/A
N/A	Any Obstructions?	N/A	N/A	Storm Grate/Utility Hazard?	N/A
	Obstruction Type			Storm Grate/Utility Type	
		N/A			N/A
			Yes	Surface Condition? (G/P)	Good

Possible Solutions:

Remove & Replace Curb Ramp With Two New Directional Ramps or Equivalent.

R304.2.2

Total Cost: \$ 3200.00
