Access Compliance Report

Public Rights-of-Way

(Curb Ramps)

| Intersection ID: 16332 | Main Street: MARYLAND_AV | Cross Street: WELLESLEY_AV | Location: NE |

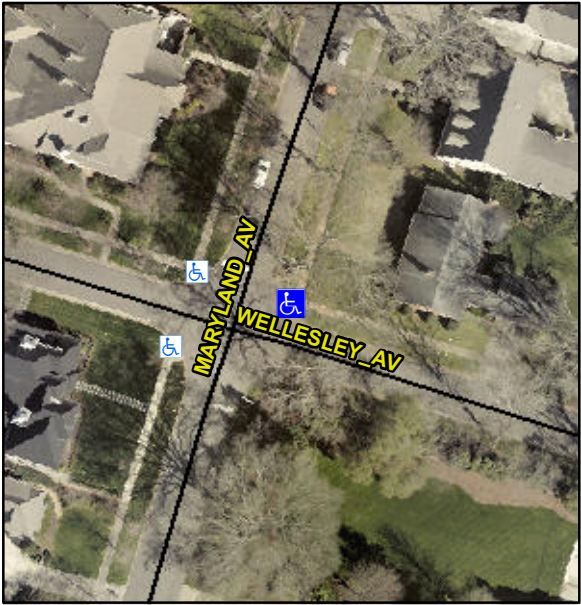
| ADA ID: 32EF724818CB | Ramp Type: PerpDiag | Initial Pass/Fail: Fail | Overall Compliance: No |

| Codes/Mitigation Info/Possible Solution | | | Field Measurements/Component Compliance | | |
|---|---|--|---|---|---|
| | Remove & Replace Curb Ramp With Two New Directional Ramps or Equivalent. | | No | Ramp Length (in) | 48.0 |
| <p>Surveyor Notes:</p> <p>N/A</p> <p>PROW/ADA:</p> <p>Not Found, R304.2.2, R304.5.3</p> | | | N/A | Flare Type RT | N/A |
| | | | No | Painted X Walk1? | No |

| Codes/Mitigation Info/Possible Solution | | | Field Measurements/Component Compliance | | |
|---|---|--|---|---|---|
| Total Cost: \$ 3200.00 | | | N/A | Storm Grate/Utility Hazard? | N/A |
