# Access Compliance Report

## Public Rights-of-Way

### (Curb Ramps)

Intersection ID: 15174		Main Street: DILWORTH_RD_WEST		Cross Street: IDEAL_WY		Location: NW																							
ADA ID: 32F2D1E8D81D		Ramp Type: Directional1		Initial Pass/Fail: Fail		Overall Compliance: No		Severity Score: 1.25																					
Codes/Mitigation Info/Possible Solution					Field Measurements/Component Compliance

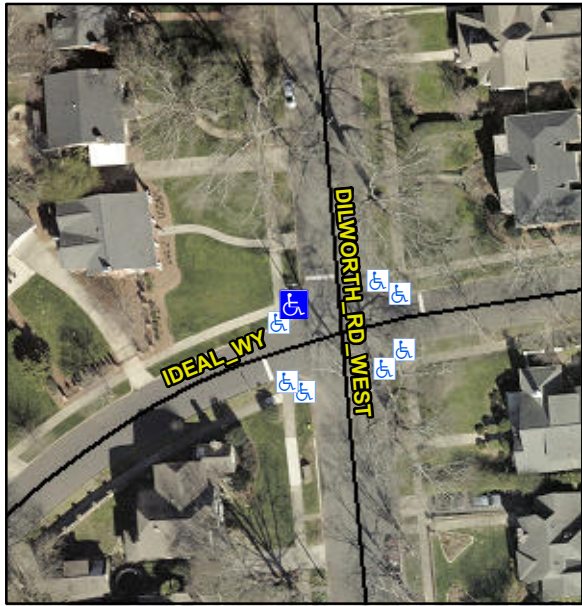
<div>Street 1 NameDILWORTH RD WEST</div> <div>Stop Condition-Street 1StopSign</div> <div>Street 2 NameN/A</div> <div>Stop Condition-Street 2N/A</div>					Possible Solutions:					ComplianceDescriptionDataComplianceDescriptionData																			
					Remove & Replace Entire Ramp.					N/A					Ramp Length (in)32.0					N/A					Grade Break?N/A				
Surveyor Notes:					N/A					Yes					Ramp Width (in)60.0					N/A					Grade Break Slope (%)0.0				
					PROW/ADA:					R304.5.3					Yes					Ramp Slope (%)5.1					N/A				
Total Cost:										\$1600.00					No					Ramp XSlope (%)2.4					N/A

N/A					Flare Type RTN/A					N/A				
															N/A					Flare Slope RT (%)N/A					N/A				
															N/A					Flare Traversable RT?N/A					N/A				
															N/A					Landing Width (in)0.0					N/A				
															N/A					Landing Slope (%)0.0					N/A				
															N/A					Landing X Slope (%)0.0					N/A				
															N/A					Landing X Slope (%)0.0					N/A				
															N/A					Landing Curb? (Y/N)N/A					N/A				
															N/A					Shared Landing?N/A					N/A				
															N/A					Gutter Ponding?0.0					N/A				
															N/A					Gutter Lip Ht (in)0.0					N/A				
															N/A					Painted X Walk1?No					Road Slope (%)6.8				
																				X Walk 1 DirectionTo NE					Road X Slope (%)0.6				
																				X Walk 1 Width (in)N/A					Clear Space?N/A				
																				X Walk 1 Slope (%)6.8					N/A				
																				X Walk 1 X Slope (%)0.6					N/A

N/A					Ramp inside XWalk1?N/A					Storm Grate/Utility Type				
															N/A					Any Obstructions?N/A					N/A				
																				Obstruction TypeYes					Surface Condition? (G/P)Good				
																				N/A					N/A
