Access Compliance Report Public Rights-of-Way (Curb Ramps)

Intersection ID: 50583 Main Street: GRAND_FIR_RD Cross Street: LONGSTRAW_RD Location: NE **Overall Compliance: No Severity Score:** ADA ID: 32F45B05A69D Ramp Type: Perp Initial Pass/Fail: Fail 22.5

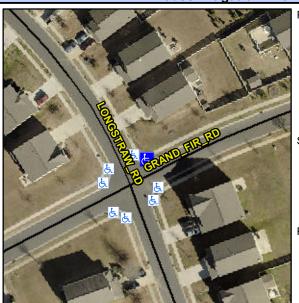
Field Measurements/Component Compliance								
Comp	liance Description	Data	Comp	liance Description	Data			
N/A	Ramp Length (in)	48.0	No	Ramp Slope (%)	8.5			
No	Ramp Width (in)	47.5	No	Ramp XSlope (%)	4.1			
N/A	Flare Type LT	N/A	N/A	Flare Type RT	N/A			
N/A	Flare Slope LT (%)	N/A	N/A	Flare Slope RT (%)	N/A			
N/A	Flare Traversable LT?	N/A	N/A	Flare Traversable RT?	N/A			
N/A	Landing Length (in)	N/A	N/A	DWS Provided?	N/A			
N/A	Landing Width (in)	N/A	N/A	DWS Contrast?	N/A			
N/A	Landing Slope (%)	N/A	N/A	DWS Length (in)	N/A			
N/A	Landing X Slope (%)	N/A	N/A	DWS Full Width?	N/A			
N/A	Landing Curb? (Y/N)	N/A	N/A	DWS Offset (in)	N/A			
N/A	Shared Landing?	N/A						
N/A	Gutter Ponding?	N/A	N/A	Gutter Slope (%)	N/A			
N/A	Gutter Lip Ht (in)	N/A	N/A	Gutter X Slope (%)	N/A			
N/A	Painted X Walk1?	No	N/A	Painted X Walk2?	N/A			
	X Walk 1 Direction	To S		X Walk 2 Direction	N/A			
N/A	X Walk 1 Width (in)	N/A	N/A	X Walk 2 Width (in)	N/A

X Walk 1 Slope (%)	2.6		X Walk 2 Slope (%)	N/A			
	X Walk 1 X Slope (%)	2.1		X Walk 2 X Slope (%)	N/A			
N/A	Ramp inside XWalk1?	N/A	N/A	Ramp inside XWalk2?	N/A			
	Road Slope (%)	N/A	N/A	Clear Space?	N/A			
	Road X Slope (%)	N/A	N/A	Clear Space to XWalk (in)	N/A			
N/A	Any Obstructions?	N/A	N/A	Storm Grate/Utility Hazard?	N/A			
	Obstruction Type			Storm Grate/Utility Type				
		N/A			N/A			
			Yes	Surface Condition? (G/P)	Good			
	10

Possible Solutions:	9
Remove & Replace Entire Ramp.	ı
•	ı
	ı
	ı
	ı
	ı
Surveyor Notes:	ı
N/A	ı
	ı
	ı
	ı
PROW/ADA:	ı
Not Found, R304.5.1, R304.2.2,	ı
R304.5.3	ı
	ı
	-
	ı
