Access Compliance Report Public Rights-of-Way (Curb Ramps)

Intersection ID: 31279 Main S	treet: MALLARD GLEN DR	Cross St	reet:	GARRETT GRIGG R	D		Location:	N
			Cross Street: GARRETT_GRIGG_RD					
ADA ID: 330CB0A8A780 Ramp Type: PerpDiag		Initial Pa	Initial Pass/Fail: Fail Overall Compliance: N				o Severity Score:	21.25
Codes/Mitigation Info/Possible Solution			Field Measurements/Component Compliance					
	Possible Solutions:	<u>(</u>	Compliance Description			Data Compliance Description		
	Remove & Replace Curb Ramp With Two New Directional Ramps or Equivalent.	/ith N	N/A	Ramp Length (in)	58.0	No	Ramp Slope (%)	10.0
		1	No	Ramp Width (in)	40.0	Yes	Ramp XSlope (%)	1.5
		١	N/A	Flare Type LT	N/A	N/A	Flare Type RT	N/A
		1	N/A	Flare Slope LT (%)	N/A	N/A	Flare Slope RT (%)	N/A
		1	N/A	Flare Traversable LT?	N/A	N/A	Flare Traversable RT?	N/A
		1	N/A	Landing Length (in)	N/A	N/A	DWS Provided?	N/A
	Surveyor Notes:	1	N/A	Landing Width (in)	N/A	N/A	DWS Contrast?	N/A
	N/A	1	N/A	Landing Slope (%)	N/A	N/A	DWS Length (in)	N/A

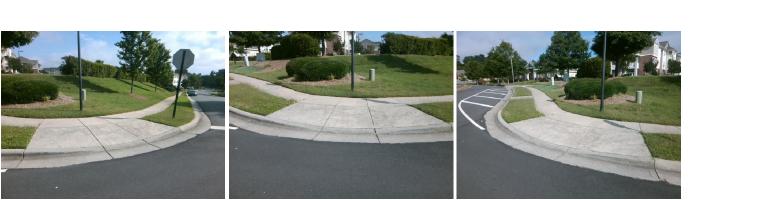
1	N/A	Landing X Slope (%)	N/A	N/A	DWS Full Width?	N/A
		1	N/A	Landing Curb? (Y/N)	N/A	N/A	DWS Offset (in)	N/A
AL 0 10 6 6		1	N/A	Shared Landing?	N/A			
	PROW/ADA:	1	N/A	Gutter Ponding?	N/A	N/A	Gutter Slope (%)	N/A
Not Found, R304.5.1, R304.2.2		N	N/A	Gutter Lip Ht (in)	N/A	N/A	Gutter X Slope (%)	N/A
		1	N/A	Painted X Walk1?	No	N/A	Painted X Walk2?	No
				X Walk 1 Direction	To SW		X Walk 2 Direction	To SE
		1	N/A	X Walk 1 Width (in)	N/A	N/A	X Walk 2 Width (in)	N/A
Street 1 Name MALLARD GLEN DR				X Walk 1 Slope (%)	1.1		X Walk 2 Slope (%)	1.7
Stop Condition-Street 2 None				X Walk 1 X Slope (%)	2.1		X Walk 2 X Slope (%)	2.9
Street 2 Name GARRETT GRIGG RE		1	N/A	Ramp inside XWalk1?	N/A	N/A	Ramp inside XWalk2?	N/A
Stop Condition-Street 1 StopSigr				Road Slope (%)	1.9	N/A	Clear Space?	N/A
				Road X Slope (%)	0.7	N/A	Clear Space to XWalk (in)	N/A
		1	N/A	Any Obstructions?	N/A	N/A	Storm Grate/Utility Hazard?	N/A
