Access Compliance Report

Public Rights-of-Way

(Curb Ramps)

| Intersection ID: N/A | Main Street: WINSLET_DR | Cross Street: N/A | Location: NE |

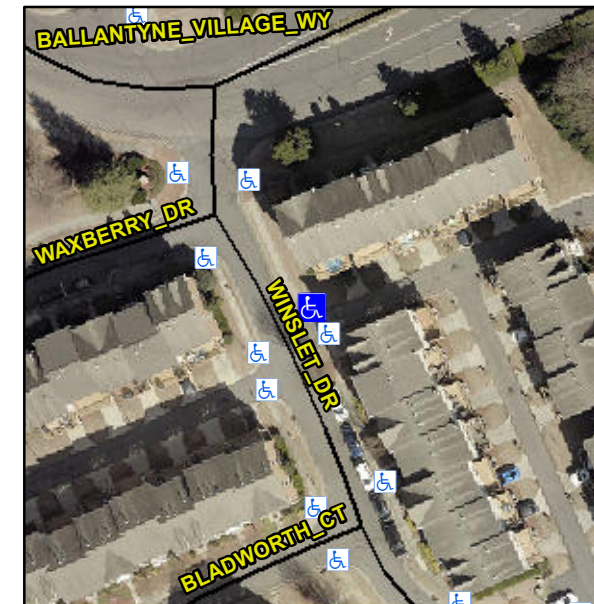
| ADA ID: 3322842E4BF5 | Ramp Type: Perp | Initial Pass/Fail: Fail | Overall Compliance: No |

Not Found, R304.5.1, R304.5.3

| Compliance | Description | Data | Compliance | Description | Data |
|---|---|---|---|---|---|
| N/A | Ramp Length (in) | 16.0 | Yes | Ramp Slope (%) | 6.0 |
| No | Ramp Width (in) | 44.0 | No | Ramp XSlope (%) | 2.1 |

Remove & Replace Entire Ramp.

Total Cost: \$ 1850.00
