Access Compliance Report

Public Rights-of-Way

(Curb Ramps)

Intersection ID: N/A	Main Street: COSTIGAN_LN	Cross Street: BALLANTYNE_VILLAGE_WY	Location: E
ADA ID: 333E2BD6305A	Ramp Type: PerpDiag	Initial Pass/Fail: Fail	Overall Compliance: No
Severity Score: 21.25			
Codes/Mitigation Info/Possible Solution		Field Measurements/Component Compliance

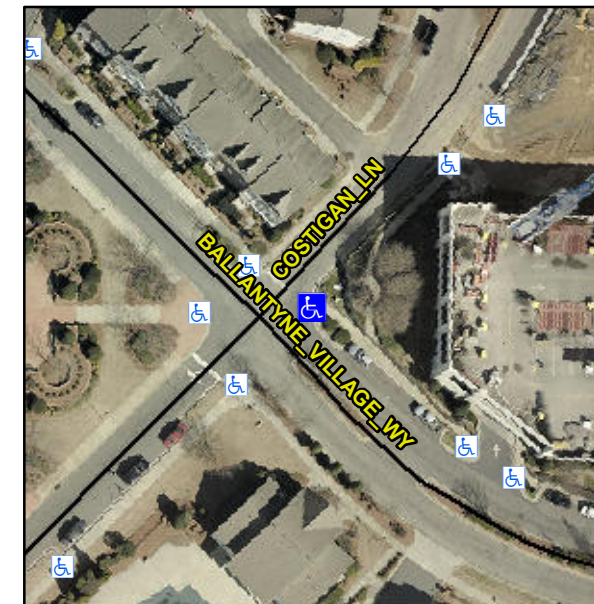
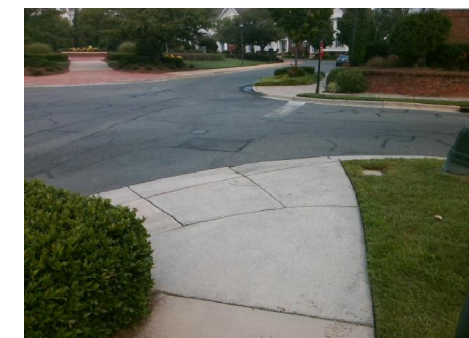
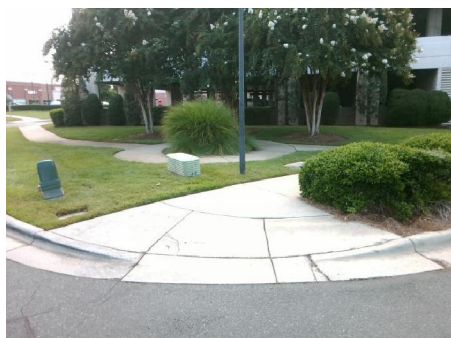
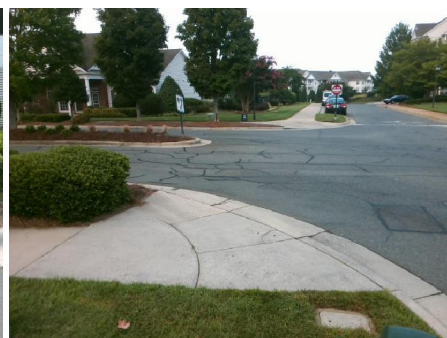
Not Found, R304.5.1, R304.5.3

Compliance	Description	Data	Compliance	Description	Data
N/A	Ramp Length (in)	52.0	Yes	Ramp Slope (%)	6.7
No	Ramp Width (in)	46.0	No	Ramp XSlope (%)	5.5
N/A	Flare Type LT	N/A	N/A	Flare Type RT	N/A
N/A	Flare Slope LT (%)	N/A	N/A	Flare Slope RT (%)	N/A
N/A	Flare Traversable LT?	N/A	N/A	Flare Traversable RT?	N/A
N/A	Landing Length (in)	N/A	N/A	DWS Provided?	N/A
N/A	Landing Width (in)	N/A	N/A	DWS Contrast?	N/A
N/A	Landing Slope (%)	N/A	N/A	DWS Length (in)	N/A
N/A	Landing X Slope (%)	N/A	N/A	DWS Full Width?	N/A
N/A	Landing Curb? (Y/N)	N/A	N/A	DWS Offset (in)	N/A
N/A	Shared Landing?	N/A			
N/A	Gutter Ponding?	N/A	N/A	Gutter Slope (%)	N/A
N/A	Gutter Lip Ht (in)	N/A	N/A	Gutter X Slope (%)	N/A
N/A	Painted X Walk1?	No	N/A	Painted X Walk2?	No
	X Walk 1 Direction	To NW		X Walk 2 Direction	To SW
N/A	X Walk 1 Width (in)	N/A	N/A	X Walk 2 Width (in)	N/A
	X Walk 1 Slope (%)	0.6		X Walk 2 Slope (%)	2.3
	X Walk 1 X Slope (%)	2.4		X Walk 2 X Slope (%)	0.6

N/A	Ramp inside XWalk1?	N/A	N/A	Ramp inside XWalk2?	N/A
	Road Slope (%)	0.8	N/A	Clear Space?	N/A
	Road X Slope (%)	1.9	N/A	Clear Space to XWalk (in)	N/A
N/A	Any Obstructions?	N/A	N/A	Storm Grate/Utility Hazard?	N/A
	Obstruction Type			Storm Grate/Utility Type	
		N/A			N/A
			Yes	Surface Condition? (G/P)	Good

Remove & Replace Curb Ramp With Two New Directional Ramps or Equivalent.
