# Access Compliance Report

## Public Rights-of-Way

### (Curb Ramps)

Intersection ID: 11108	Main Street: TUCKASEEGEE_RD	Cross Street: N/A	Location: NE
ADA ID: 3364188CF46E	Ramp Type: Perp	Initial Pass/Fail: Fail	Overall Compliance: No
Codes/Mitigation Info/Possible Solution			Severity Score: 33.75
			Field Measurements/Component Compliance

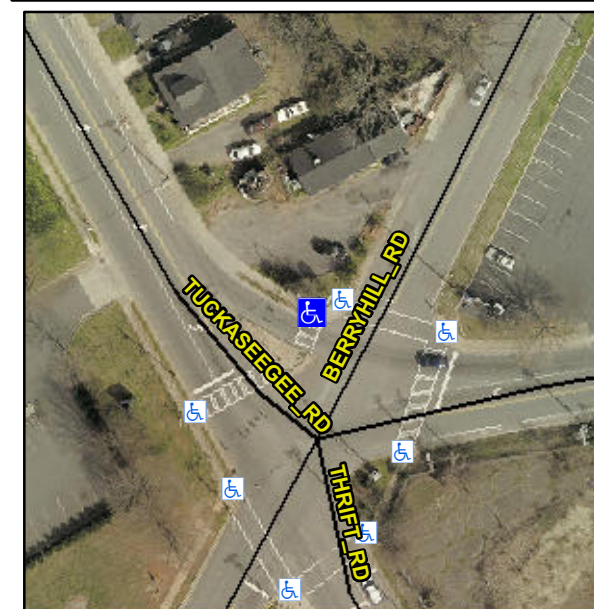
**Not Found, R304.5.1, R304.2.2, R304.5.3**

Compliance	Description	Data	Compliance	Description	Data
N/A	Ramp Length (in)	73.0	No	Ramp Slope (%)	11.5
No	Ramp Width (in)	46.0	No	Ramp XSlope (%)	5.7
N/A	Flare Type LT	N/A	N/A	Flare Type RT	N/A
N/A	Flare Slope LT (%)	N/A	N/A	Flare Slope RT (%)	N/A
N/A	Flare Traversable LT?	N/A	N/A	Flare Traversable RT?	N/A
N/A	Landing Length (in)	N/A	N/A	DWS Provided?	N/A
N/A	Landing Width (in)	N/A	N/A	DWS Contrast?	N/A
N/A	Landing Slope (%)	N/A	N/A	DWS Length (in)	N/A
N/A	Landing X Slope (%)	N/A	N/A	DWS Full Width?	N/A
N/A	Landing Curb? (Y/N)	N/A	N/A	DWS Offset (in)	N/A
N/A	Shared Landing?	N/A			
N/A	Gutter Ponding?	N/A	N/A	Gutter Slope (%)	N/A
N/A	Gutter Lip Ht (in)	N/A	N/A	Gutter X Slope (%)	N/A
N/A	Painted X Walk1?	Yes	N/A	Painted X Walk2?	N/A
	X Walk 1 Direction	To SW		X Walk 2 Direction	N/A
N/A	X Walk 1 Width (in)	111.0	N/A	X Walk 2 Width (in)	N/A
	X Walk 1 Slope (%)	7.0		X Walk 2 Slope (%)	N/A
	X Walk 1 X Slope (%)	2.7		X Walk 2 X Slope (%)	N/A

N/A	Ramp inside XWalk1?	Yes	N/A	Ramp inside XWalk2?	N/A
	Road Slope (%)	N/A	N/A	Clear Space?	N/A
	Road X Slope (%)	N/A	N/A	Clear Space to XWalk (in)	N/A
N/A	Any Obstructions?	N/A	N/A	Storm Grate/Utility Hazard?	N/A
	Obstruction Type			Storm Grate/Utility Type	
		N/A			N/A
			Yes	Surface Condition? (G/P)	Good

**Remove & Replace Entire Ramp.**
