# Access Compliance Report

## Public Rights-of-Way

### (Curb Ramps)

| Intersection ID: 48644 | Main Street: SOCATA_WY | Cross Street: ROCKY_FORD_CLUB_RD | Location: E |

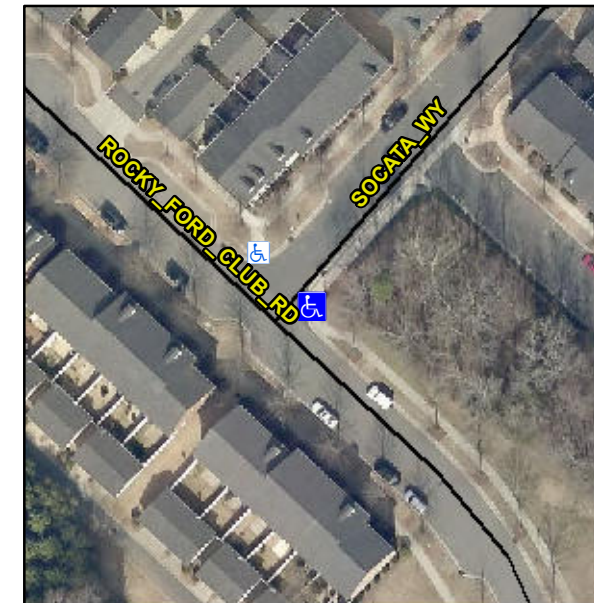
| ADA ID: 3378135B1DAB | Ramp Type: Combination1 | Initial Pass/Fail: Fail | Overall Compliance: No |
| | | Severity Score: 35 | |

**RT RP < 5%**

**R304.5.1, R304.5.3, R304.3.2**

| Compliance | Description | Data | Compliance | Description | Data |
|---|---|---|---|---|---|
| N/A | Ramp Length LT (in) | 45.0 | N/A | Ramp Length RT (in) | 25.5 |
| No | Ramp Width LT (in) | 44.0 | No | Ramp Width RT (in) | 44.0 |
| No | Ramp Slope LT (%) | 12.6 | Yes | Ramp Slope RT (%) | 3.2 |
| Yes | Ramp XSlope LT (%) | 0.1 | No | Ramp XSlope RT (%) | 2.1 |
| N/A | Ramp Length (in) | 28.0 | Yes | Ramp Slope (%) | 6.5 |
| Yes | Ramp Width (in) | 48.0 | No | Ramp XSlope (%) | 4.9 |

Possible Solutions:

**Remove & Replace Entire Ramp.**

Total Cost: \$ 1800.00
