Access Compliance Report

Public Rights-of-Way

(Curb Ramps)

Intersection ID: 11541	Main Street: W_9TH_ST	Cross Street: N_PINE_ST	Location: E
ADA ID: 33817FBD73ED	Ramp Type: PerpDiag	Initial Pass/Fail: Fail	Overall Compliance: No
		Severity Score: 12.5

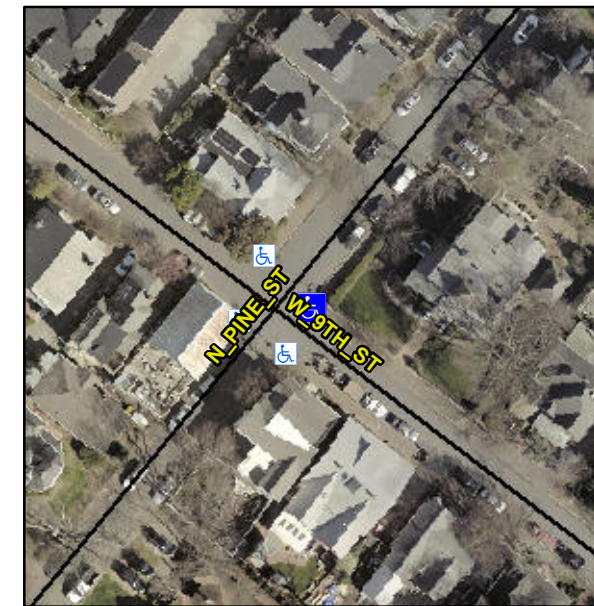
Not Found, R304.2.2

Compliance	Description	Data	Compliance	Description	Data
N/A	Ramp Length (in)	73.0	No	Ramp Slope (%)	10.7
Yes	Ramp Width (in)	48.0	Yes	Ramp XSlope (%)	1.5
N/A	Flare Type LT	N/A	N/A	Flare Type RT	N/A
N/A	Flare Slope LT (%)	N/A	N/A	Flare Slope RT (%)	N/A
N/A	Flare Traversable LT?	N/A	N/A	Flare Traversable RT?	N/A
N/A	Landing Length (in)	N/A	N/A	DWS Provided?	N/A
N/A	Landing Width (in)	N/A	N/A	DWS Contrast?	N/A
N/A	Landing Slope (%)	N/A	N/A	DWS Length (in)	N/A
N/A	Landing X Slope (%)	N/A	N/A	DWS Full Width?	N/A
N/A	Landing Curb? (Y/N)	N/A	N/A	DWS Offset (in)	N/A
N/A	Shared Landing?	N/A			
N/A	Gutter Ponding?	N/A	N/A	Gutter Slope (%)	N/A
N/A	Gutter Lip Ht (in)	N/A	N/A	Gutter X Slope (%)	N/A
N/A	Painted X Walk1?	No	N/A	Painted X Walk2?	No
	X Walk 1 Direction	To NW		X Walk 2 Direction	To SW
N/A	X Walk 1 Width (in)	N/A	N/A	X Walk 2 Width (in)	N/A
	X Walk 1 Slope (%)	4.4		X Walk 2 Slope (%)	2.4
	X Walk 1 X Slope (%)	1.3		X Walk 2 X Slope (%)	0.4

N/A	Ramp inside XWalk1?	N/A	N/A	Ramp inside XWalk2?	N/A
	Road Slope (%)	2.7	N/A	Clear Space?	N/A
	Road X Slope (%)	3.5	N/A	Clear Space to XWalk (in)	N/A
N/A	Any Obstructions?	N/A	N/A	Storm Grate/Utility Hazard?	N/A
	Obstruction Type			Storm Grate/Utility Type	
		N/A			N/A
			Yes	Surface Condition? (G/P)	Good

Remove & Replace Curb Ramp With Two New Directional Ramps or Equivalent.
