# Access Compliance Report

## Public Rights-of-Way

### (Curb Ramps)

| Intersection ID: 29822 | Main Street: WILKLEE_DR | Cross Street: STURKIE_CT | Location: SE |

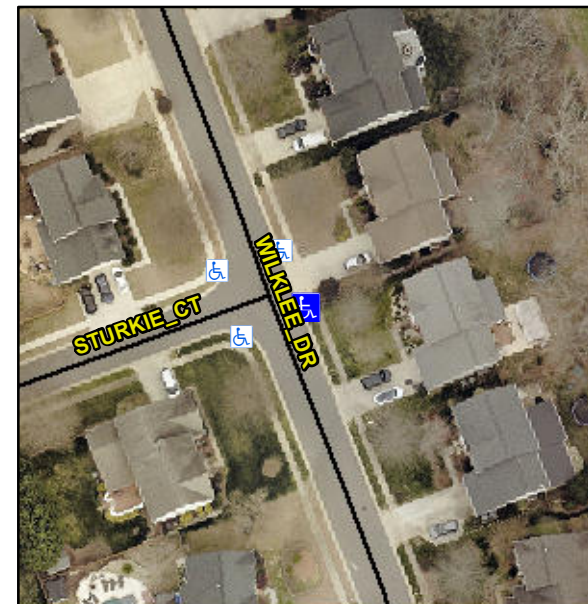
| ADA ID: 338A3246BED6 | Ramp Type: Perp | Initial Pass/Fail: Fail | Overall Compliance: No |

| Compliance | Description | Data | Compliance | Description | Data |
|---|---|---|---|---|---|
| N/A | Ramp Length (in) | 47.0 | No | Ramp Slope (%) | 9.6 |
| No | Ramp Width (in) | 46.0 | No | Ramp XSlope (%) | 7.7 |

**Remove & Replace Entire Ramp.**
