## **Access Compliance Report Public Rights-of-Way** (Curb Ramps)

Intersection ID: 48436 Main Street: BEDLINGTON RD **Cross Street: ORANSAY WY** Location: NE **Overall Compliance: No ADA ID: 3397E9C1AFE2** Ramp Type: PerpDiag Initial Pass/Fail: Fail Severity Score: 13.75

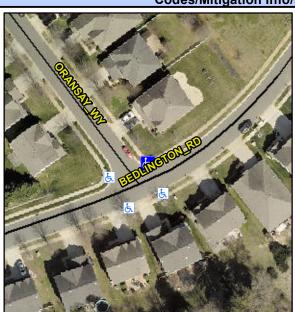
Compliance Description Data Compliance Description Data No amp Length (in) 46.0 Ramp Slope (%) 9.3 No Ramp XSlope (%) amp Width (in) 48.0 3.9 N/A lare Type LT N/A Flare Type RT N/A N/A N/A Flare Slope RT (%) N/A lare Slope LT (%) lare Traversable LT? N/A N/A Flare Traversable RT? N/A N/A N/A DWS Provided? N/A anding Length (in) anding Width (in) N/A N/A **DWS Contrast?** N/A N/A N/A anding Slope (%) DWS Length (in) N/A anding X Slope (%) N/A N/A DWS Full Width? N/A anding Curb? (Y/N) N/A N/A DWS Offset (in) N/A N/A hared Landing? Sutter Ponding? N/A N/A Gutter Slope (%) N/A Sutter Lip Ht (in) N/A N/A Gutter X Slope (%) N/A ainted X Walk1? No N/A Painted X Walk2? No Walk 1 Direction To W X Walk 2 Direction To SE N/A Walk 1 Width (in) X Walk 2 Width (in) N/A Walk 1 Slope (%) 2.0 X Walk 2 Slope (%) 2.1 Walk 1 X Slope (%) 2.5 X Walk 2 X Slope (%) 2.6 N/A N/A Ramp inside XWalk2? N/A amp inside XWalk1? oad Slope (%) 0.2 N/A Clear Space? N/A N/A 2.7 Clear Space to XWalk (in) N/A oad X Slope (%) N/A N/A ny Obstructions? Storm Grate/Utility Hazard? N/A **Obstruction Type** Storm Grate/Utility Type N/A N/A

Street 1 Name Stop Condition-Street 2 Street 2 Name Stop Condition-Street 1 Remove & Replace Curb Ramp With Two New Directional Ramps or Equivalent.

R304.2.2, R304.5.3
