Intersection ID: 6599	Main Street: BRADEN_DR	Cross Street: DEDMON_DR	Location:	NW
ADA ID: 339B9098490E	Ramp Type: Perp	Initial Pass/Fail: Fail	Overall Compliance: No	Severity Score: 1.25

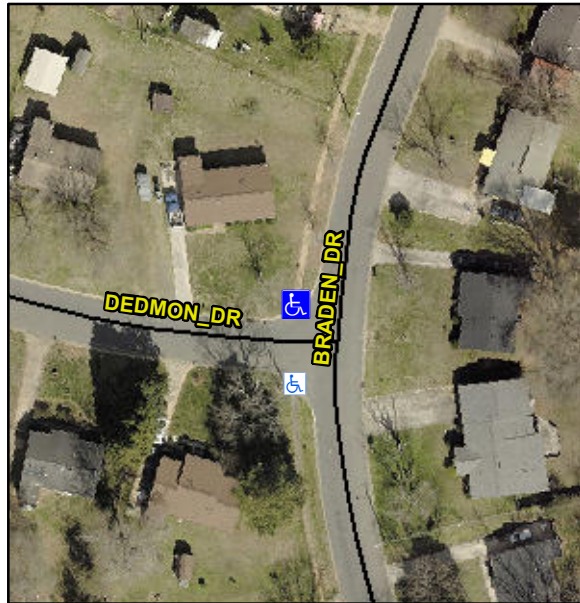
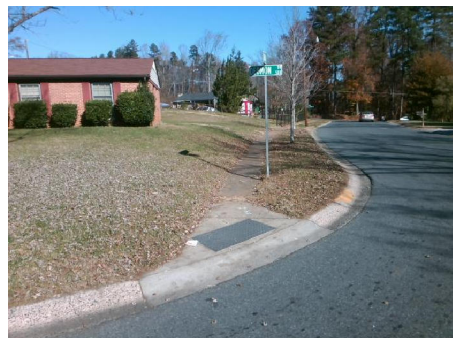
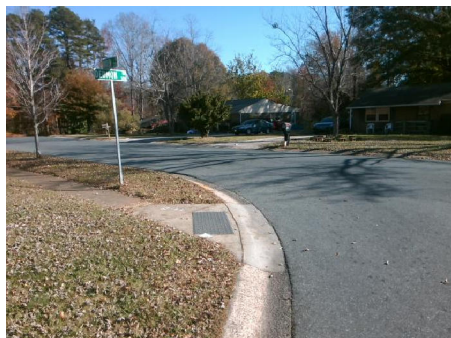
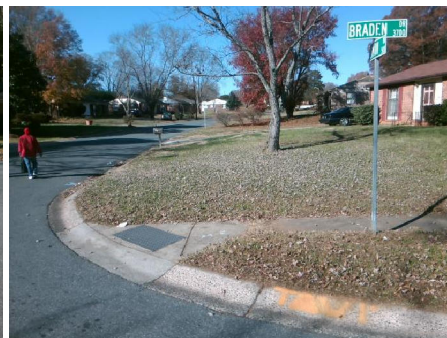
## Not Found, R304.5.3

Possible Solutions:			Compliance	Description	Data	Compliance	Description	Data
<b>Remove &amp; Replace Entire Ramp.</b>			N/A	Ramp Length (in)	54.0	Yes	Ramp Slope (%)	5.9
			Yes	Ramp Width (in)	48.0	No	Ramp XSlope (%)	2.3
			N/A	Flare Type LT	N/A	N/A	Flare Type RT	N/A
			N/A	Flare Slope LT (%)	N/A	N/A	Flare Slope RT (%)	N/A
			N/A	Flare Traversable LT?	N/A	N/A	Flare Traversable RT?	N/A
			N/A	Landing Length (in)	N/A	N/A	DWS Provided?	N/A
			N/A	Landing Width (in)	N/A	N/A	DWS Contrast?	N/A
			N/A	Landing Slope (%)	N/A	N/A	DWS Length (in)	N/A
			N/A	Landing X Slope (%)	N/A	N/A	DWS Full Width?	N/A
			N/A	Landing Curb? (Y/N)	N/A	N/A	DWS Offset (in)	N/A
Surveyor Notes: <b>N/A</b>			N/A	Shared Landing?	N/A			
			N/A	Gutter Ponding?	N/A	N/A	Gutter Slope (%)	N/A
			N/A	Gutter Lip Ht (in)	N/A	N/A	Gutter X Slope (%)	N/A
			N/A	Painted X Walk1?	No	N/A	Painted X Walk2?	N/A
				X Walk 1 Direction	To S		X Walk 2 Direction	N/A

N/A	X Walk 1 Width (in)	N/A	N/A	X Walk 2 Width (in)	N/A
				X Walk 1 Slope (%)	0.2		X Walk 2 Slope (%)	N/A
				X Walk 1 X Slope (%)	0.8		X Walk 2 X Slope (%)	N/A
			N/A	Ramp inside XWalk1?	N/A	N/A	Ramp inside XWalk2?	N/A
				Road Slope (%)	N/A	N/A	Clear Space?	N/A
PROW/ADA: <b>Not Found, R304.5.3</b>				Road X Slope (%)	N/A	N/A	Clear Space to XWalk (in)	N/A
			N/A	Any Obstructions?	N/A	N/A	Storm Grate/Utility Hazard?	N/A
				Obstruction Type			Storm Grate/Utility Type	
					N/A			N/A
						Yes	Surface Condition? (G/P)	Good
Total Cost:			\$	1850.00

### Remove & Replace Entire Ramp.
