# Access Compliance Report

## Public Rights-of-Way

### (Curb Ramps)

Intersection ID: 10037289	Main Street: SARDIS_RD_NORTH	Cross Street: N/A	Location: W
ADA ID: 33A460DFF25C	Ramp Type: PerpDiag	Initial Pass/Fail: Fail	Overall Compliance: No
		Severity Score: 12.5

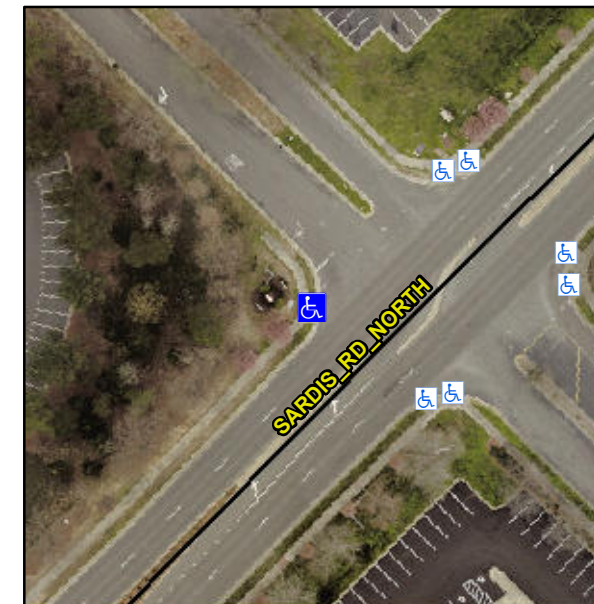
**Not Found, R304.5.3**

Compliance	Description	Data	Compliance	Description	Data
N/A	Ramp Length (in)	96.0	Yes	Ramp Slope (%)	5.8
Yes	Ramp Width (in)	53.0	No	Ramp XSlope (%)	6.2
N/A	Flare Type LT	N/A	N/A	Flare Type RT	N/A
N/A	Flare Slope LT (%)	N/A	N/A	Flare Slope RT (%)	N/A
N/A	Flare Traversable LT?	N/A	N/A	Flare Traversable RT?	N/A
N/A	Landing Length (in)	N/A	N/A	DWS Provided?	N/A
N/A	Landing Width (in)	N/A	N/A	DWS Contrast?	N/A
N/A	Landing Slope (%)	N/A	N/A	DWS Length (in)	N/A
N/A	Landing X Slope (%)	N/A	N/A	DWS Full Width?	N/A
N/A	Landing Curb? (Y/N)	N/A	N/A	DWS Offset (in)	N/A
N/A	Shared Landing?	N/A			
N/A	Gutter Ponding?	N/A	N/A	Gutter Slope (%)	N/A
N/A	Gutter Lip Ht (in)	N/A	N/A	Gutter X Slope (%)	N/A
N/A	Painted X Walk1?	No	N/A	Painted X Walk2?	No
	X Walk 1 Direction	To SE		X Walk 2 Direction	To NE
N/A	X Walk 1 Width (in)	N/A	N/A	X Walk 2 Width (in)	N/A
	X Walk 1 Slope (%)	1.8		X Walk 2 Slope (%)	2.8
	X Walk 1 X Slope (%)	1.5		X Walk 2 X Slope (%)	3.1

N/A	Ramp inside XWalk1?	N/A	N/A	Ramp inside XWalk2?	N/A
	Road Slope (%)	2.1	N/A	Clear Space?	N/A
	Road X Slope (%)	0.6	N/A	Clear Space to XWalk (in)	N/A
N/A	Any Obstructions?	N/A	N/A	Storm Grate/Utility Hazard?	N/A
	Obstruction Type			Storm Grate/Utility Type	
		N/A			N/A
		Yes		Surface Condition? (G/P)	Good

**Remove & Replace Curb Ramp With Two New Directional Ramps or Equivalent.**
