Intersection ID: 11602	Main Street: E_19TH_ST	Cross Street: N_MCDOWELL_ST	Location:	N
ADA ID: 33A9BC5F13BB	Ramp Type: PerpDiag	Initial Pass/Fail: Fail	Overall Compliance: No	Severity Score: 72.5

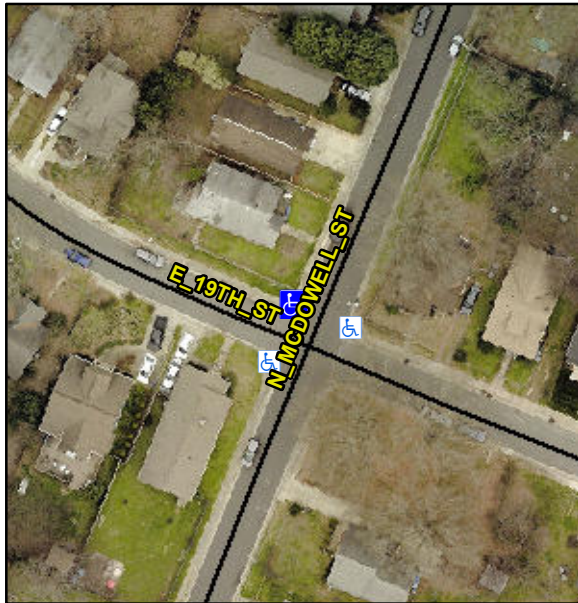
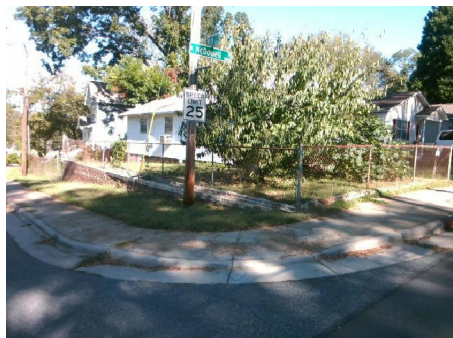
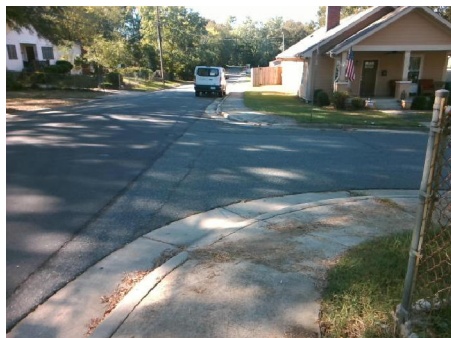
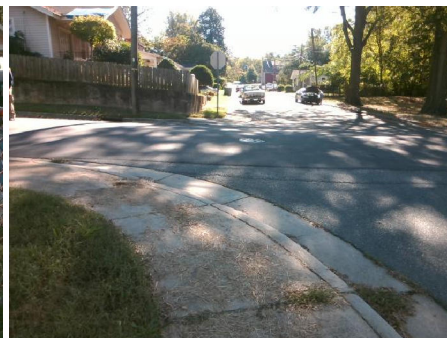
**Not Found, R304.5.1, R304.2.2,
R304.5.3**

Possible Solutions:			Compliance	Description	Data	Compliance	Description	Data
Remove & Replace Curb Ramp With Two New Directional Ramps or Equivalent.	N/A	Ramp Length (in)	47.0	No	Ramp Slope (%)	11.3		
	No	Ramp Width (in)	26.5	No	Ramp XSlope (%)	13.4		
	N/A	Flare Type LT	N/A	N/A	Flare Type RT	N/A		
	N/A	Flare Slope LT (%)	N/A	N/A	Flare Slope RT (%)	N/A		
	N/A	Flare Traversable LT?	N/A	N/A	Flare Traversable RT?	N/A		
	N/A	Landing Length (in)	N/A	N/A	DWS Provided?	N/A		
	N/A	Landing Width (in)	N/A	N/A	DWS Contrast?	N/A		
	N/A	Landing Slope (%)	N/A	N/A	DWS Length (in)	N/A		
	N/A	Landing X Slope (%)	N/A	N/A	DWS Full Width?	N/A		
	N/A	Landing Curb? (Y/N)	N/A	N/A	DWS Offset (in)	N/A		
Surveyor Notes: N/A	N/A	Shared Landing?	N/A					
	N/A	Gutter Ponding?	N/A	N/A	Gutter Slope (%)	N/A		
	N/A	Gutter Lip Ht (in)	N/A	N/A	Gutter X Slope (%)	N/A		
	N/A	Painted X Walk1?	No	N/A	Painted X Walk2?	No		
		X Walk 1 Direction	To SW		X Walk 2 Direction	To SE

N/A	X Walk 1 Width (in)	N/A	N/A	X Walk 2 Width (in)	N/A		
		X Walk 1 Slope (%)	4.7		X Walk 2 Slope (%)	6.7		
		X Walk 1 X Slope (%)	6.5		X Walk 2 X Slope (%)	5.4		
	N/A	Ramp inside XWalk1?	N/A	N/A	Ramp inside XWalk2?	N/A		
		Road Slope (%)	9.3	N/A	Clear Space?	N/A		
PROW/ADA: Not Found, R304.5.1, R304.2.2, R304.5.3		Road X Slope (%)	2.1	N/A	Clear Space to XWalk (in)	N/A		
	N/A	Any Obstructions?	N/A	N/A	Storm Grate/Utility Hazard?	N/A		
		Obstruction Type			Storm Grate/Utility Type			
			N/A			N/A		
				Yes	Surface Condition? (G/P)	Good		
	Total Cost:	\$	3200.00

Remove & Replace Curb Ramp With Two New Directional Ramps or Equivalent.
