# Access Compliance Report

## Public Rights-of-Way

### (Curb Ramps)

Intersection ID: 6578	Main Street: CAPPS_HILL_DR	Cross Street: CAPPS_HILL_MINE_RD	Location: SE
ADA ID: 33AD6B02C312	Ramp Type: Perp	Initial Pass/Fail: Fail	Overall Compliance: No
Severity Score: 46.25			
Codes/Mitigation Info/Possible Solution		Field Measurements/Component Compliance

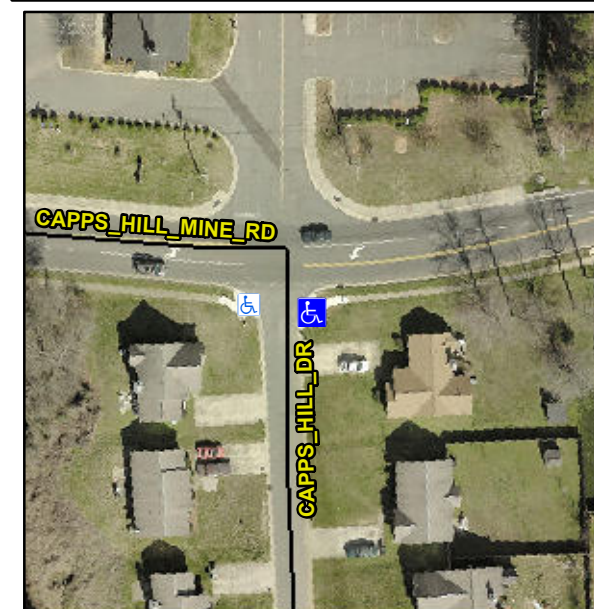
**Not Found, R304.5.1, R304.2.2, R304.5.3**

Compliance	Description	Data	Compliance	Description	Data
N/A	Ramp Length (in)	48.0	No	Ramp Slope (%)	10.6
No	Ramp Width (in)	46.0	No	Ramp XSlope (%)	7.7
N/A	Flare Type LT	N/A	N/A	Flare Type RT	N/A
N/A	Flare Slope LT (%)	N/A	N/A	Flare Slope RT (%)	N/A
N/A	Flare Traversable LT?	N/A	N/A	Flare Traversable RT?	N/A
N/A	Landing Length (in)	N/A	N/A	DWS Provided?	N/A
N/A	Landing Width (in)	N/A	N/A	DWS Contrast?	N/A
N/A	Landing Slope (%)	N/A	N/A	DWS Length (in)	N/A
N/A	Landing X Slope (%)	N/A	N/A	DWS Full Width?	N/A
N/A	Landing Curb? (Y/N)	N/A	N/A	DWS Offset (in)	N/A
N/A	Shared Landing?	N/A			
N/A	Gutter Ponding?	N/A	N/A	Gutter Slope (%)	N/A
N/A	Gutter Lip Ht (in)	N/A	N/A	Gutter X Slope (%)	N/A
N/A	Painted X Walk1?	No	N/A	Painted X Walk2?	N/A
	X Walk 1 Direction	To W		X Walk 2 Direction	N/A
N/A	X Walk 1 Width (in)	N/A	N/A	X Walk 2 Width (in)	N/A
	X Walk 1 Slope (%)	6.7		X Walk 2 Slope (%)	N/A
	X Walk 1 X Slope (%)	0.6		X Walk 2 X Slope (%)	N/A

N/A	Ramp inside XWalk1?	N/A	N/A	Ramp inside XWalk2?	N/A
	Road Slope (%)	N/A	N/A	Clear Space?	N/A
	Road X Slope (%)	N/A	N/A	Clear Space to XWalk (in)	N/A
N/A	Any Obstructions?	N/A	N/A	Storm Grate/Utility Hazard?	N/A
	Obstruction Type			Storm Grate/Utility Type	
		N/A			N/A
			Yes	Surface Condition? (G/P)	Good

Possible Solutions:

**Remove & Replace Entire Ramp.**
